DEPT. NAT. RES & ENV

PE904881

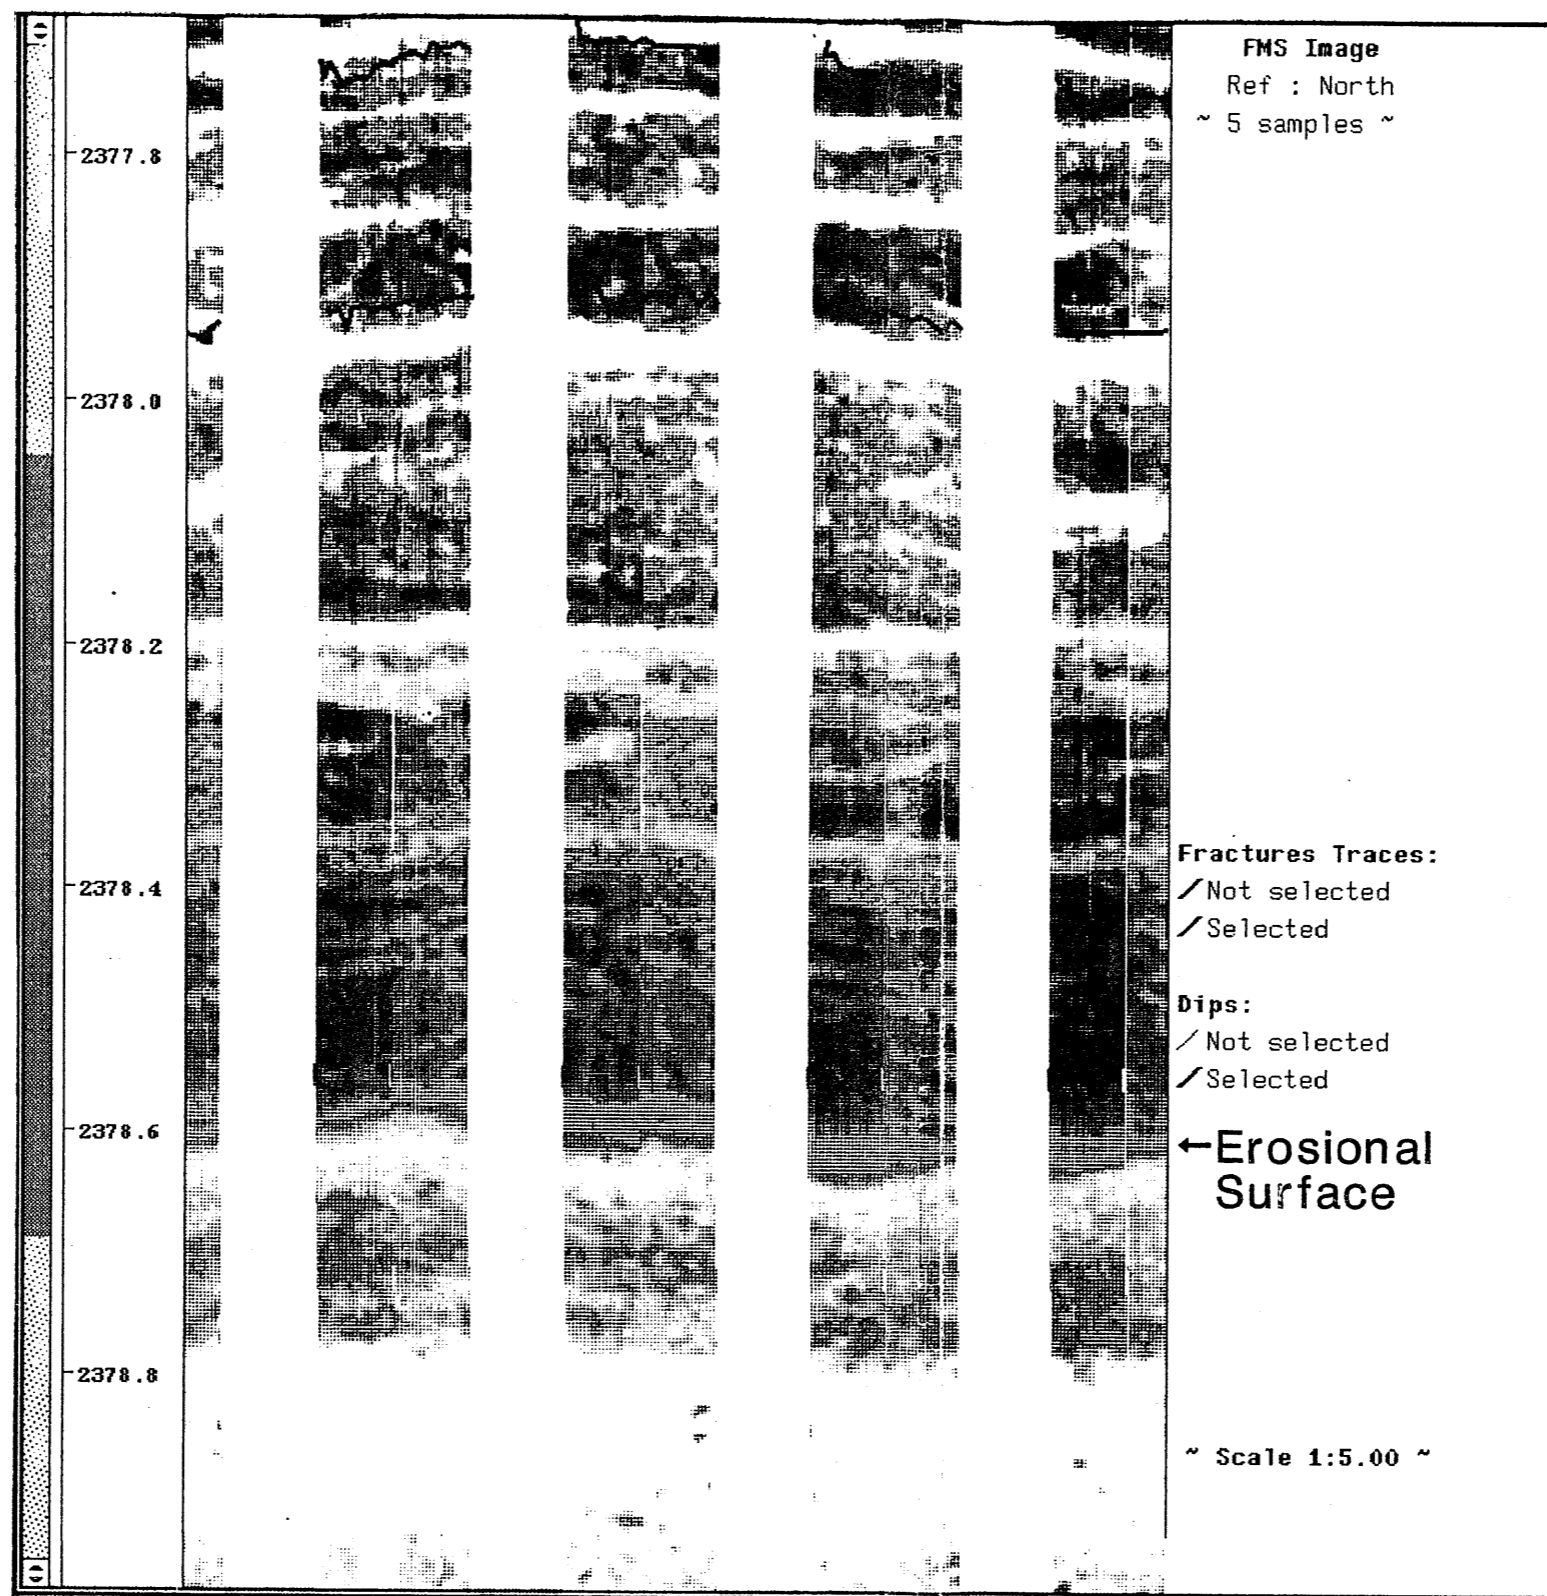
Figure 13 Erosional unconformity at base of main reservoir sand, 2378.6m.
