**PETROGRAPHIC ANALYSIS  
REPORT**

**ANEMONE 1 & 1A**

PETROGRAPHIC ANALYSIS REPORT

**ANEMONE #1, #1A**

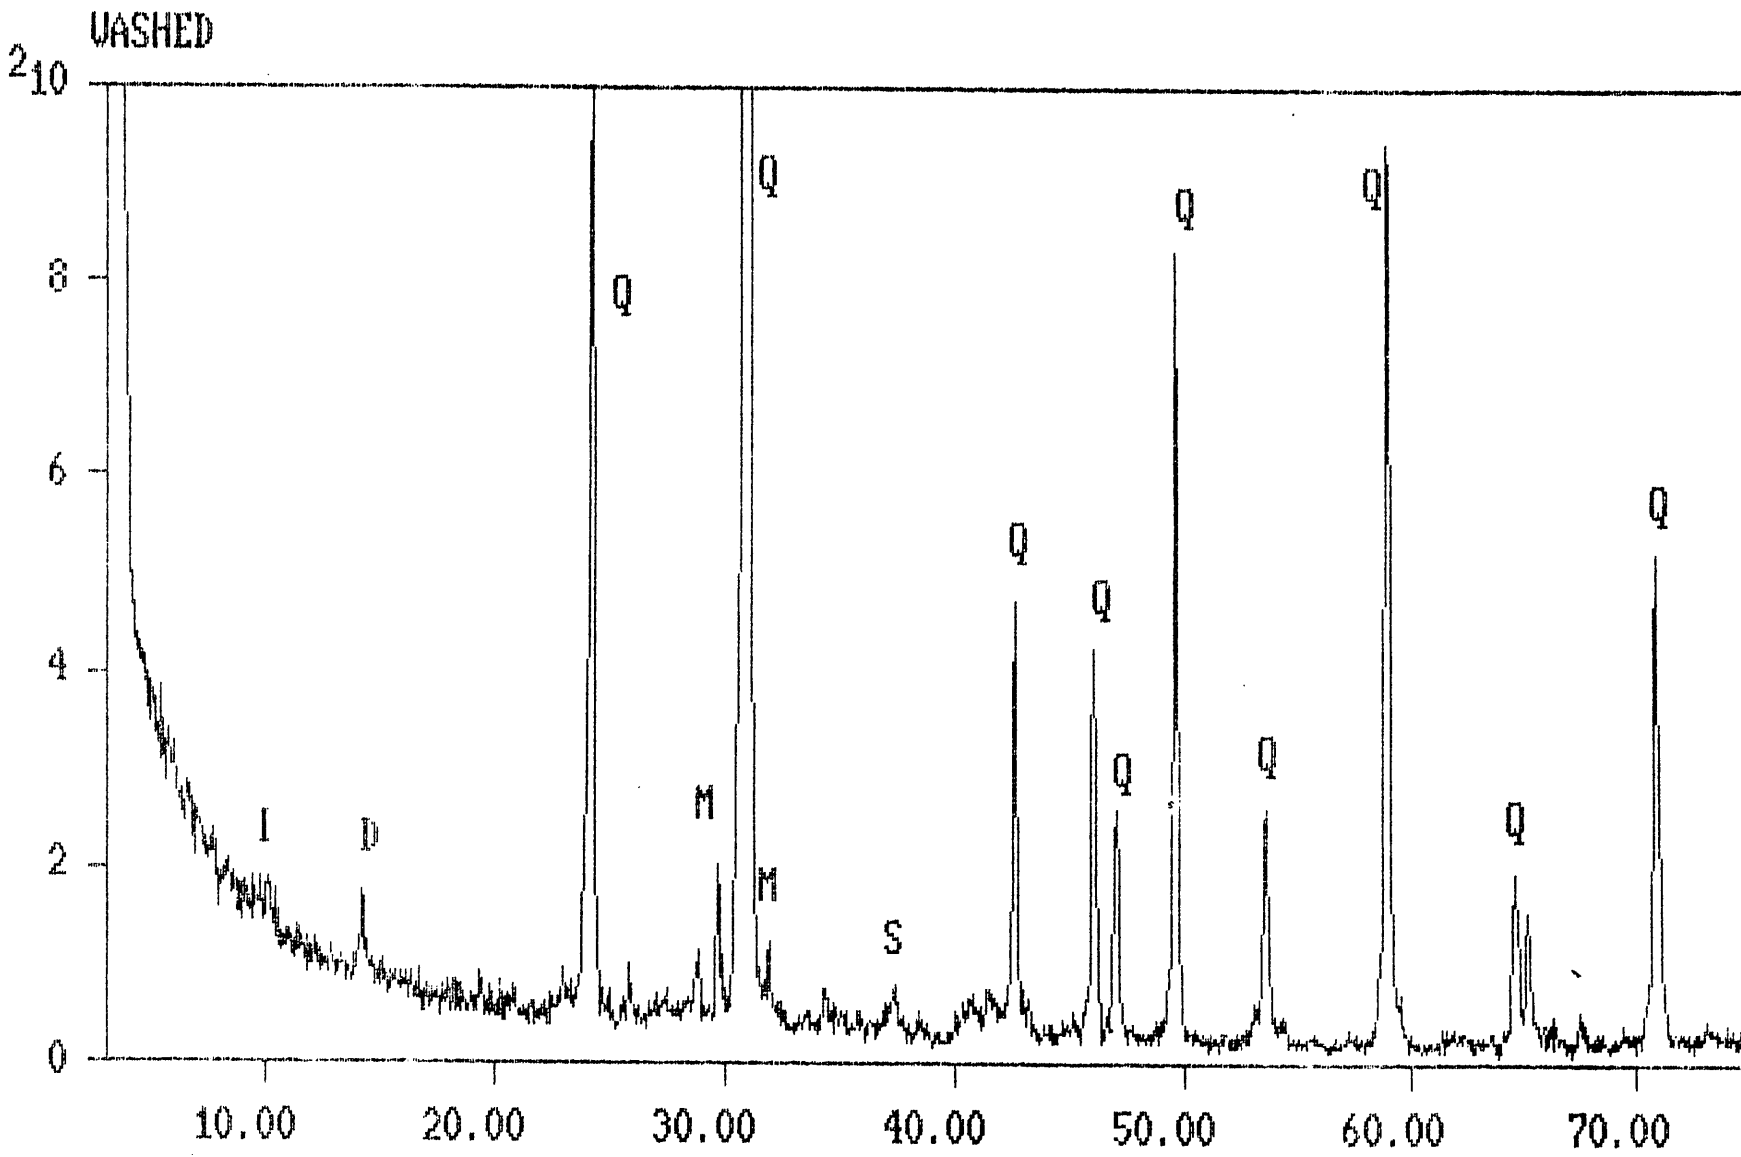
Figure 4. Anemone #1A, cuttings 4530-35m. XRD scan of the washed sample. Quartz (Q) is dominant with minor dickite (D) and microcline (M) and traces of illite (I) and siderite (S).

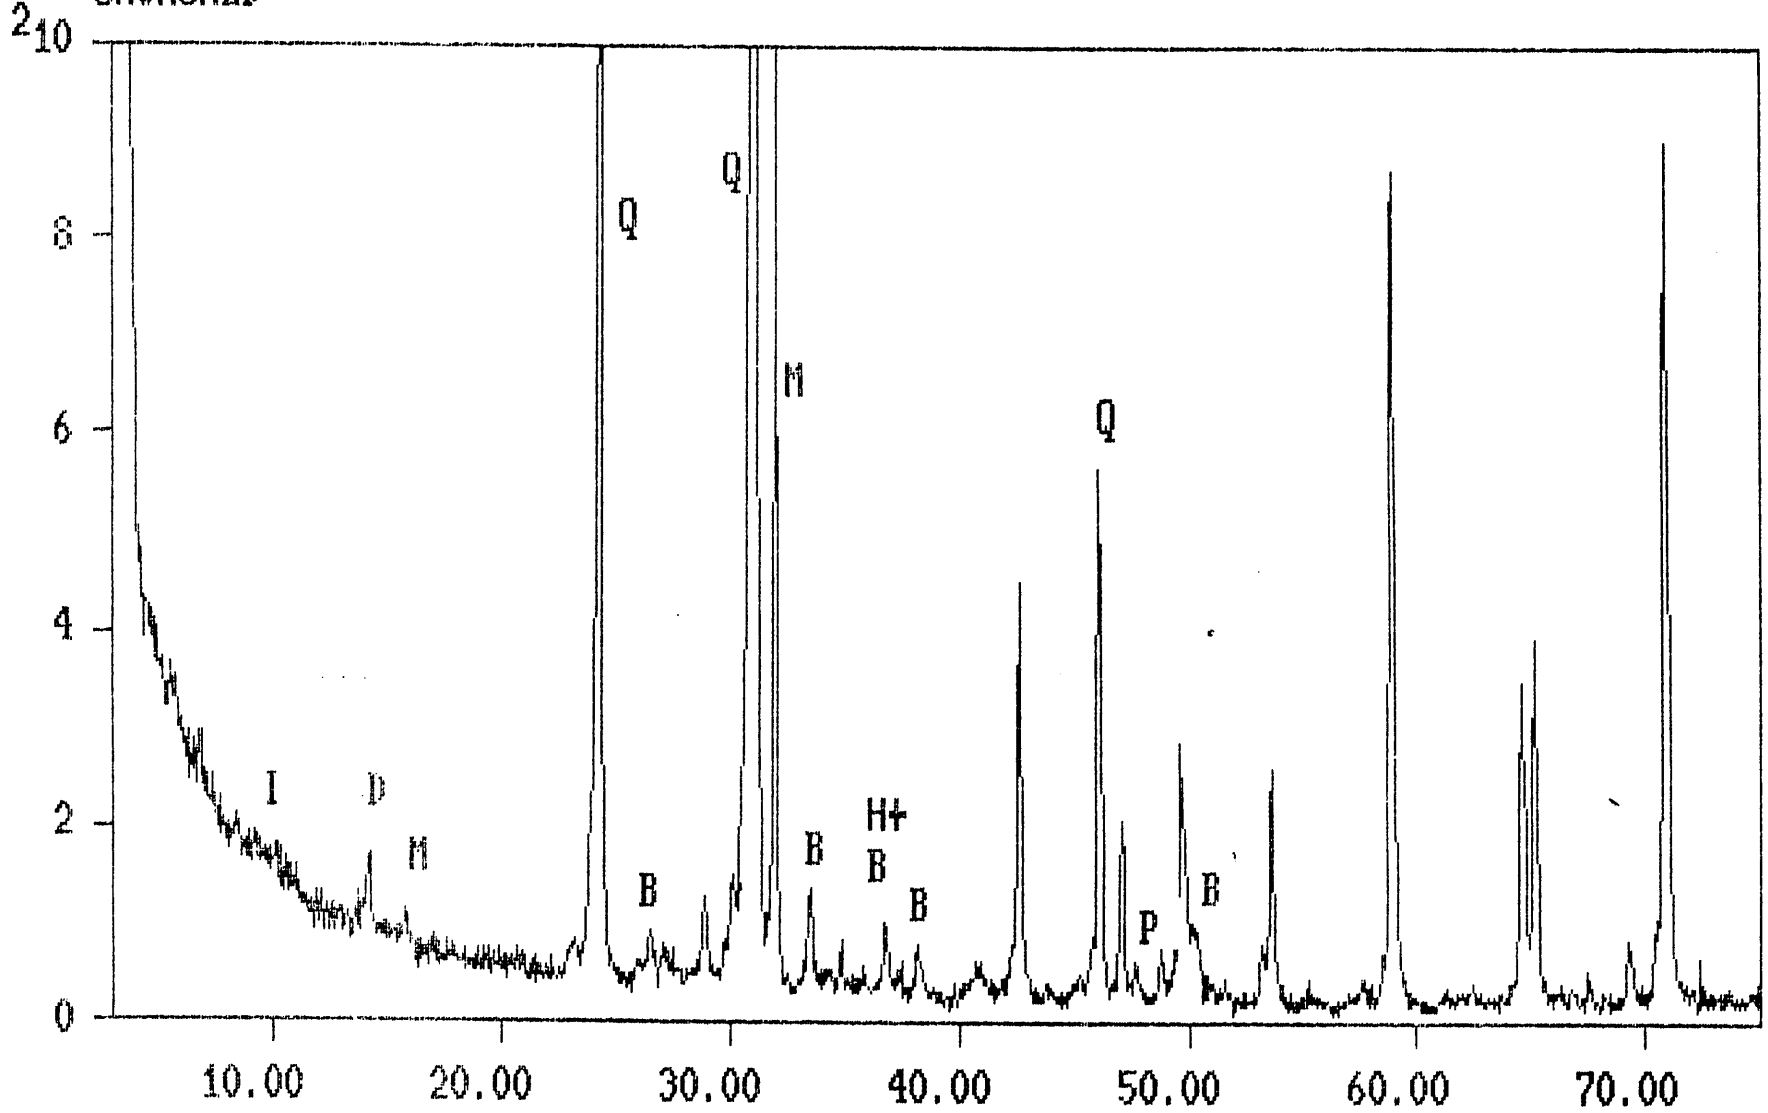
Figure 9. Anemone #1A, cuttings 4535-40m. XRD scan of the unwashed sample. Contamination by barite (B) with traces of halite (H) and pyrite (P) is superimposed on the minerals in the washed sample, quartz (Q), dickite (D) and illite (I). The dramatic increase in the microcline (M) peak is probably a function of sampling such a coarse sediment. One or two granules of microcline in the small XRD sample appear to have biased the results.

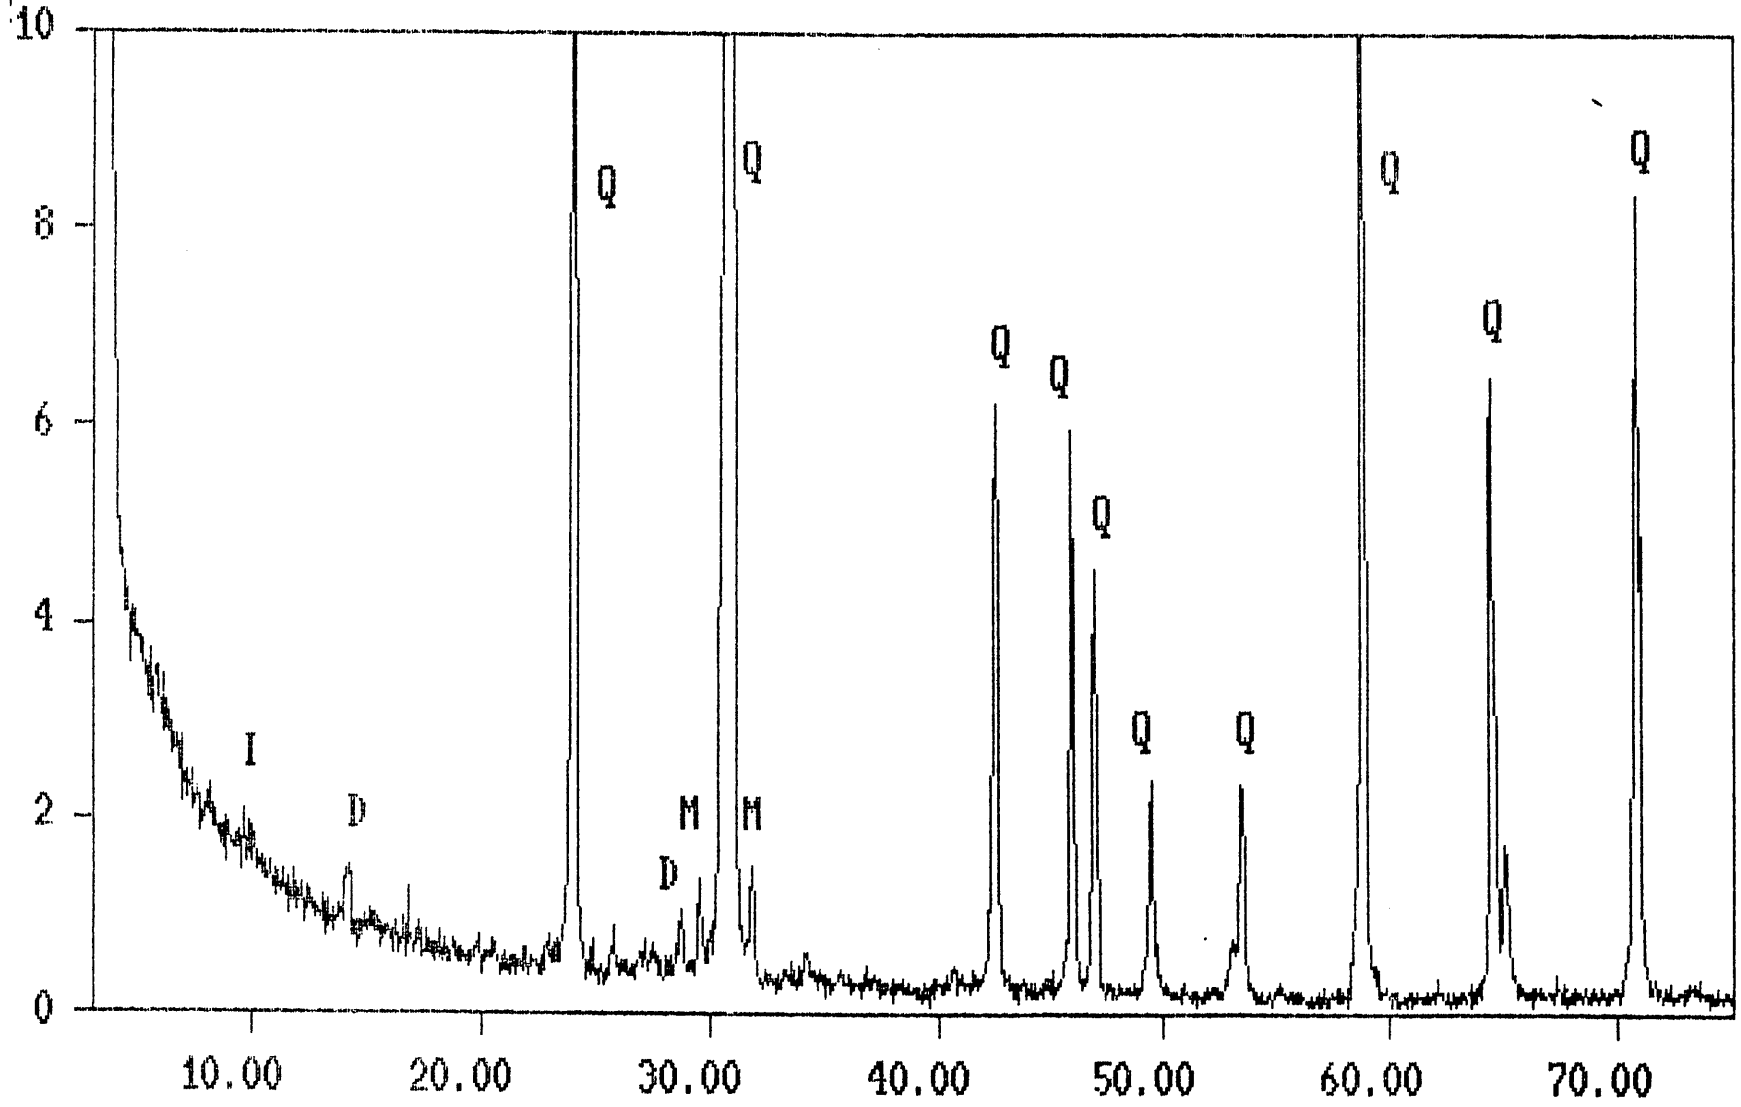
Figure 14. Anemone #1A, cuttings 4540-45m. XRD scan of the washed sample. Quartz (Q) is the dominant mineral with minor microcline (M). There are traces of the clays, illite (I) and dickite (D).

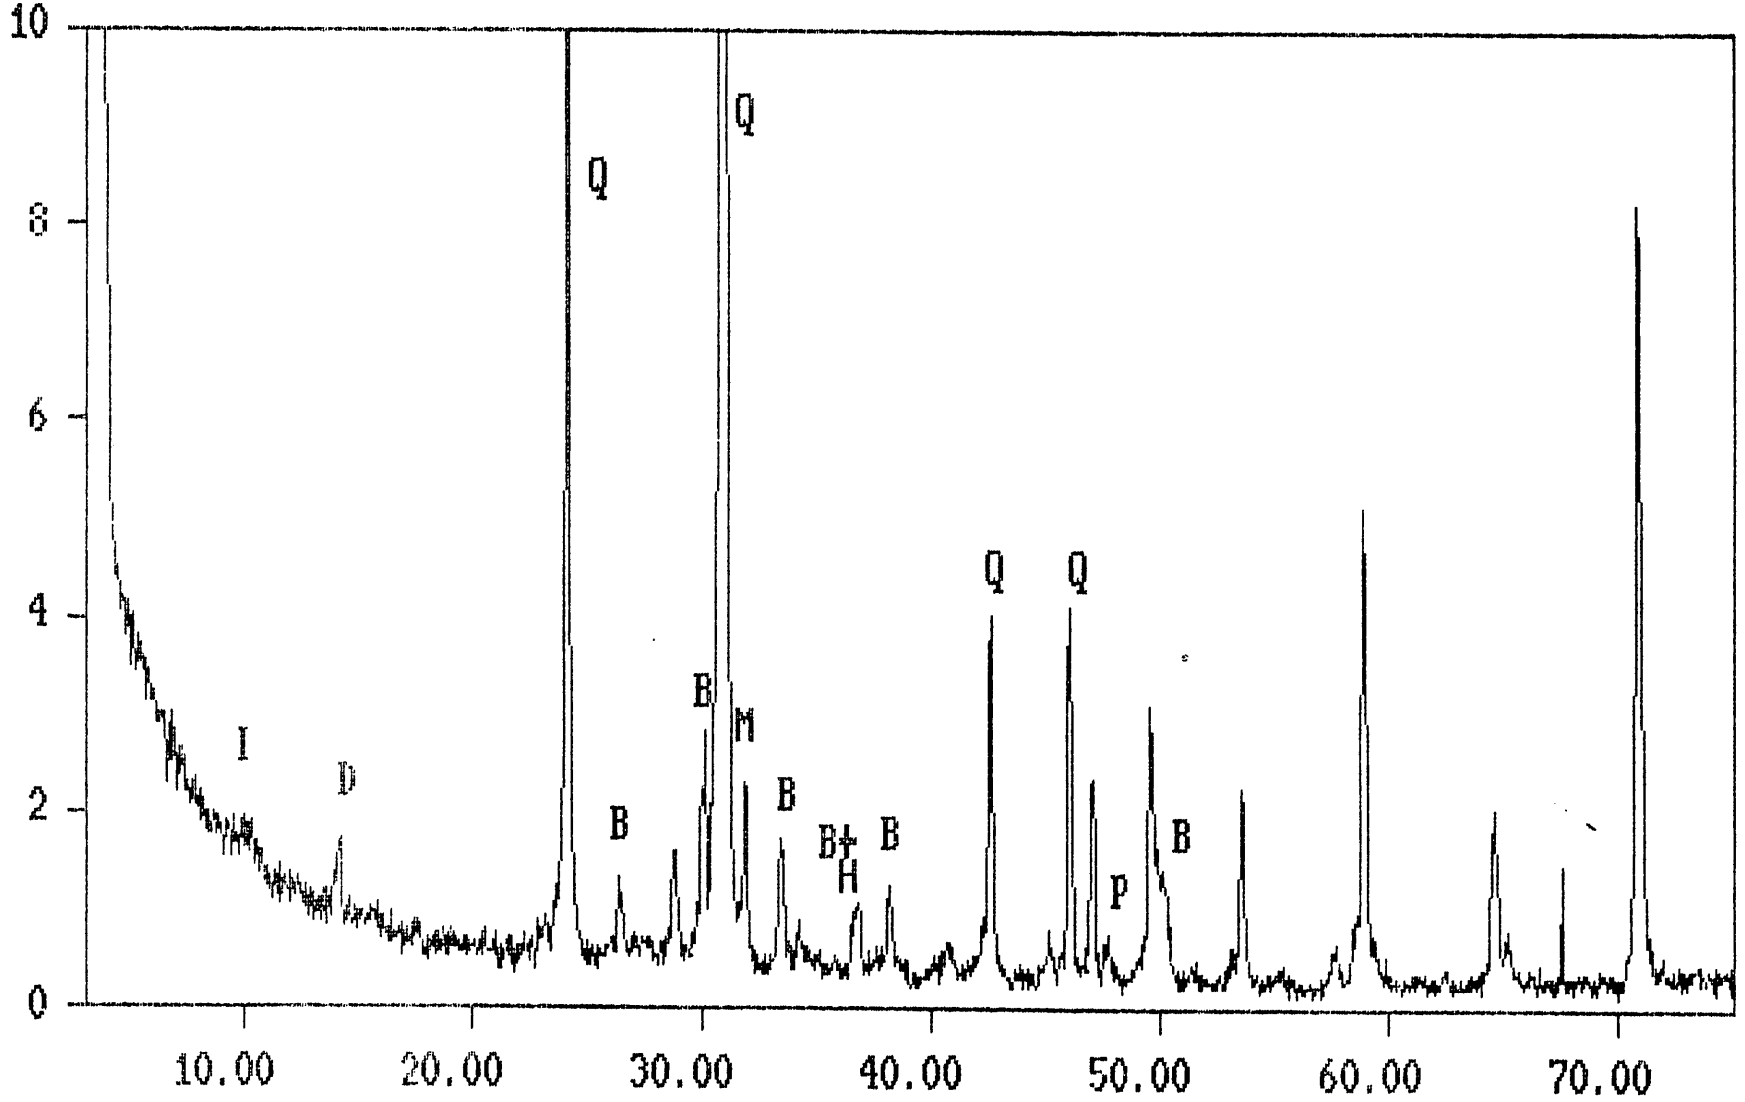
Figure 15. Anemone #1A, cuttings 4540-45m. XRD scan of the unwashed sample. Contaminants from the drilling mud, barite (B) with traces of halite (H) and pyrite (P), are superimposed on the minerals observed in the clean sample, quartz (Q), microcline (M), illite (I) and dickite (D).

**Figure 15.** Anemone #1A, cuttings 4540-45m. XRD scan of the unwashed sample. Contaminants from the drilling mud, barite (B) with traces of halite (H) and pyrite (P), are superimposed on the minerals observed in the clean sample, quartz (Q), microcline (M), illite (I) and dickite (D).

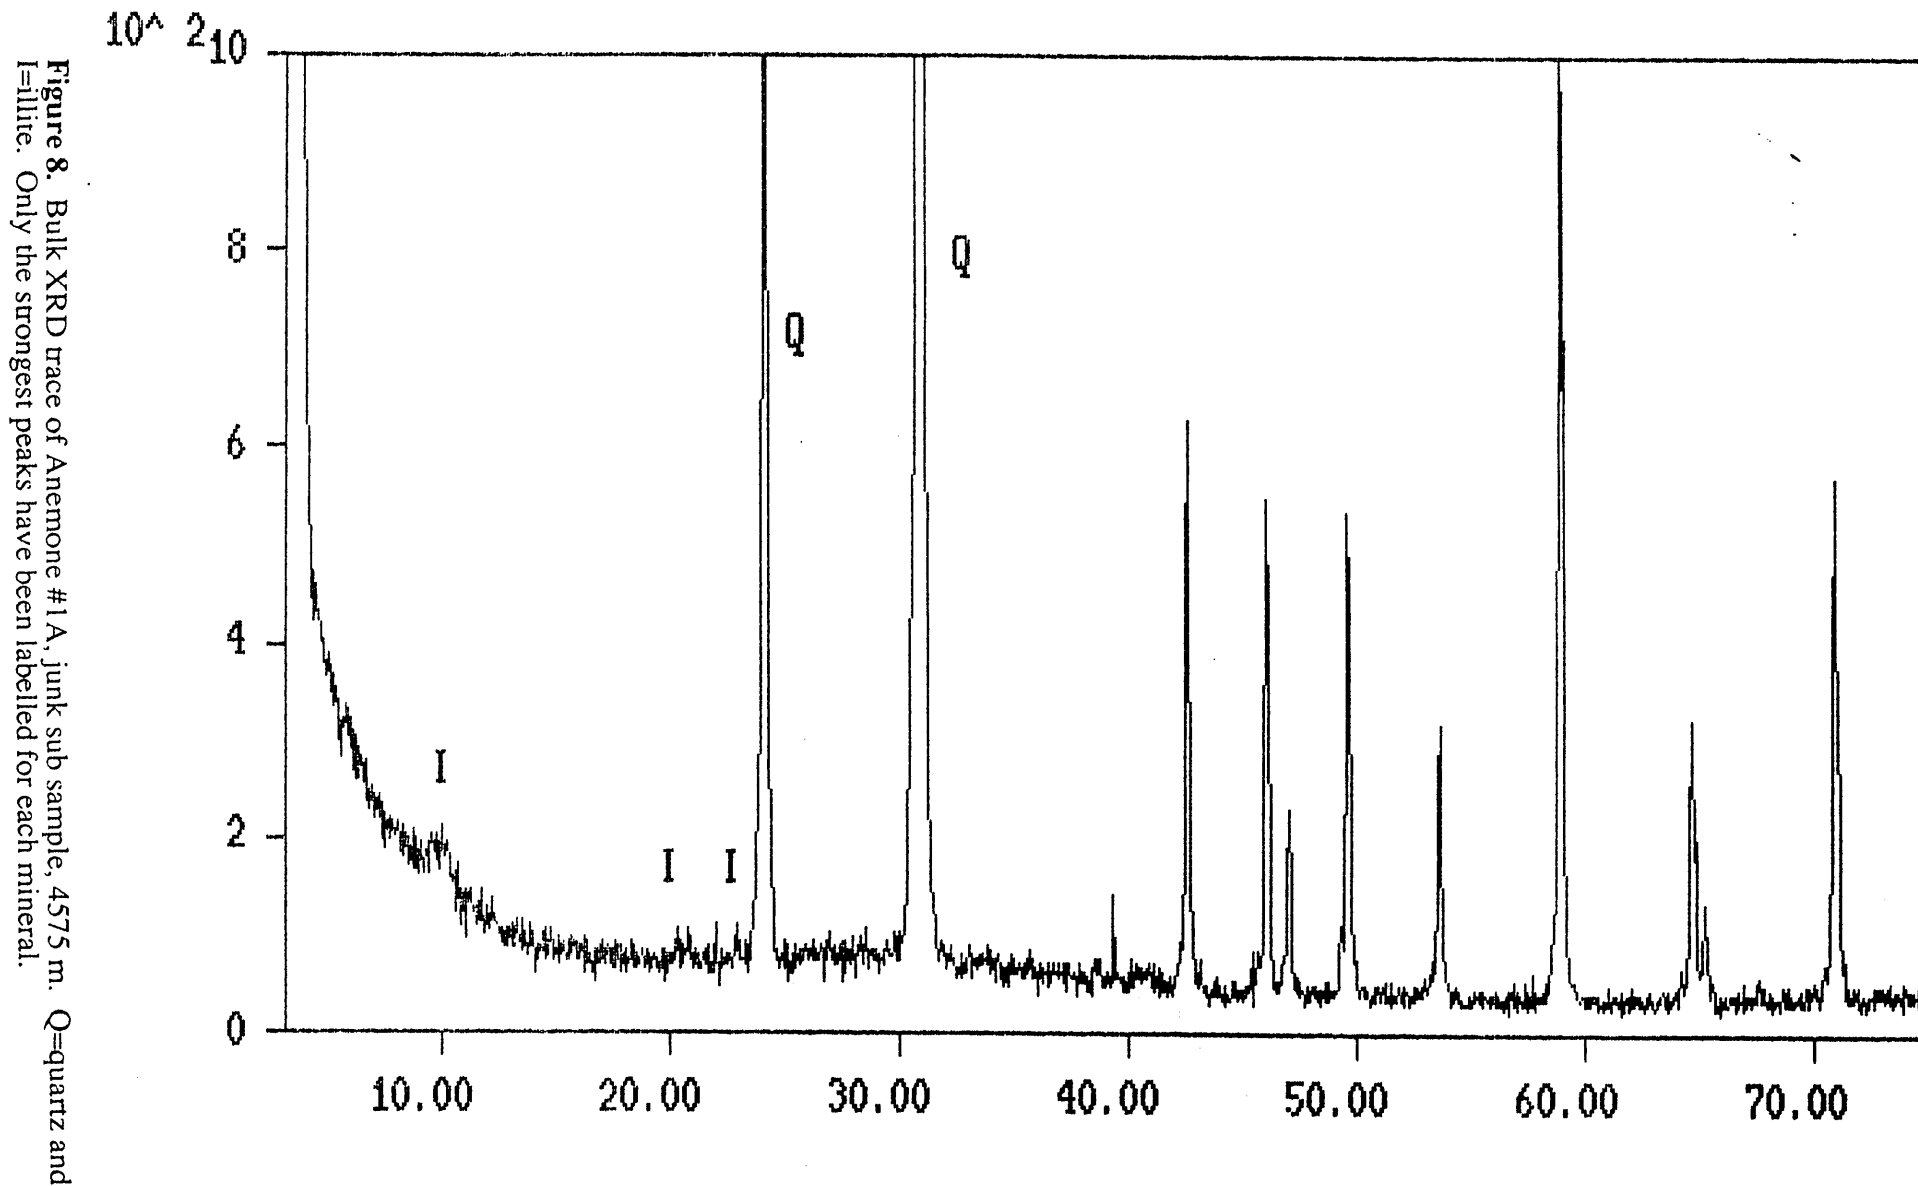
Figure 8. Bulk XRD trace of Anemone #1A, junk sub sample, 4575 m. Q=quartz and I=illite. Only the strongest peaks have been labelled for each mineral.

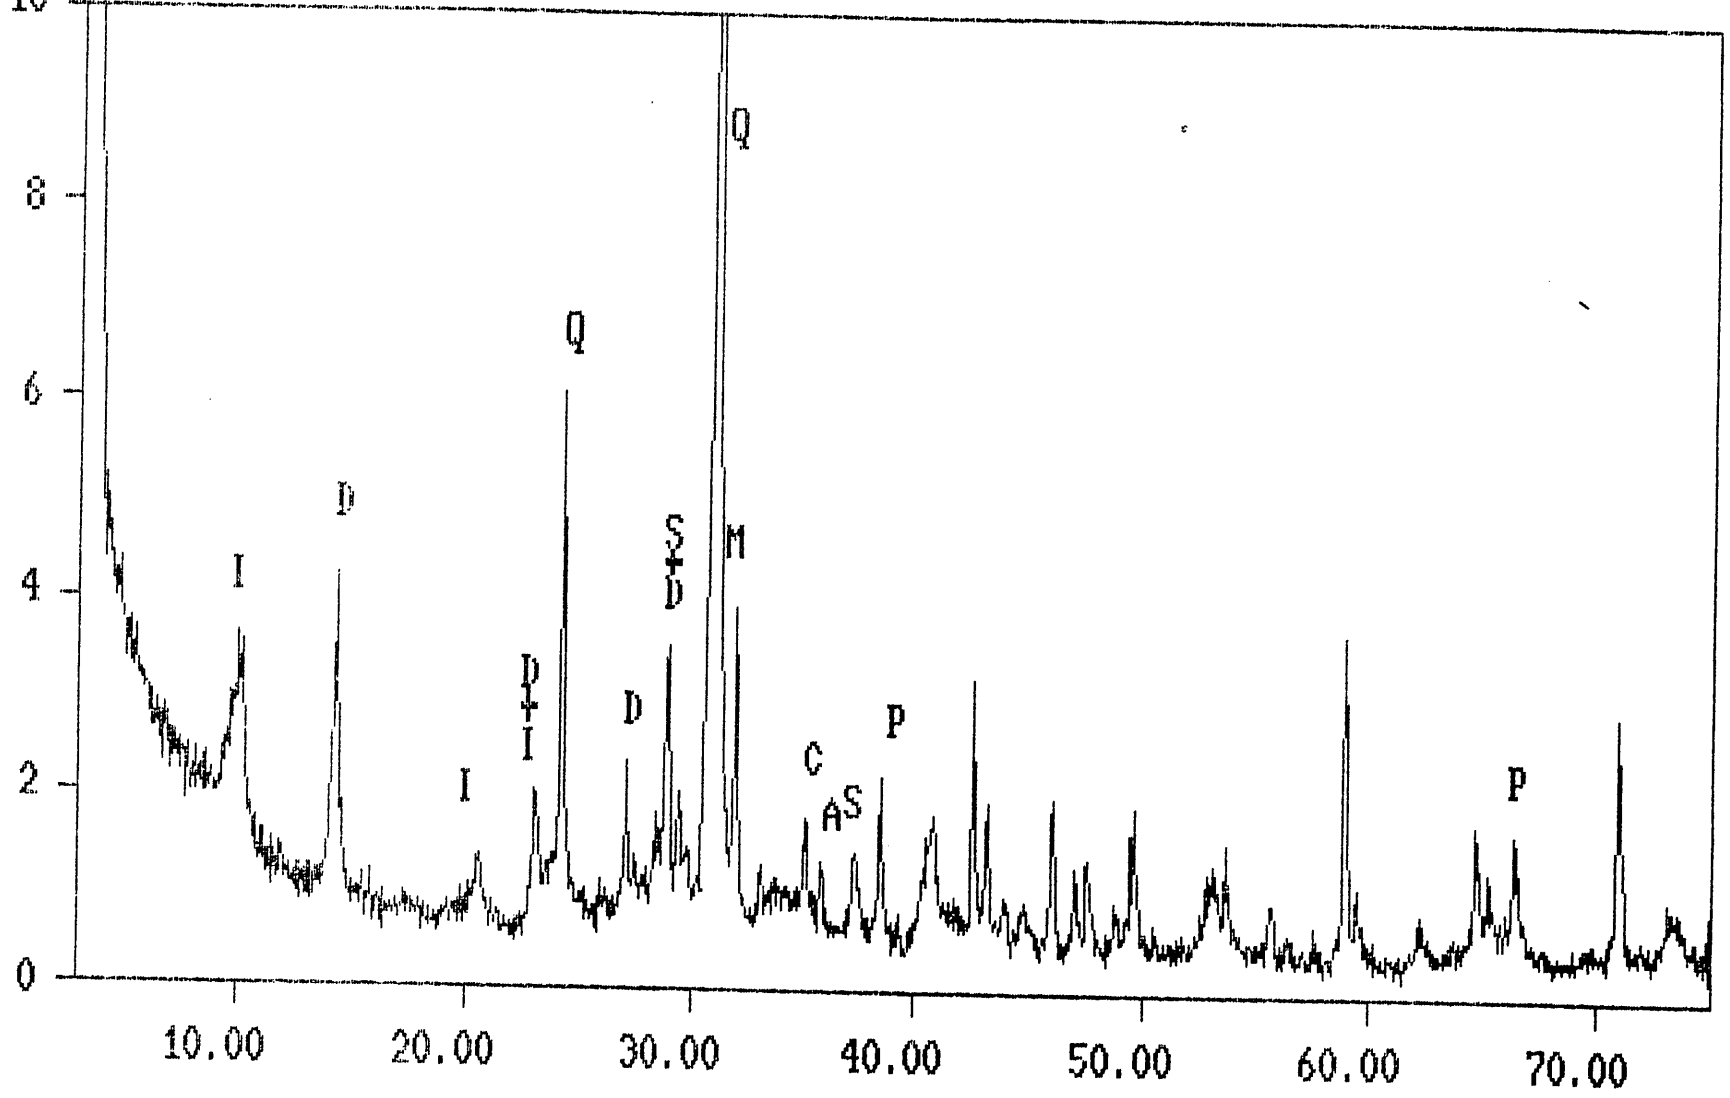
Figure 15. Bulk XRD trace of Anemone #1A, junk sub sample, 4676a m. Q=quartz, I=illite/muscovite, D=dickite, M=microcline, P=pyrite, S=siderite and A=ankerite. Only the strongest peaks have been labelled for each mineral.

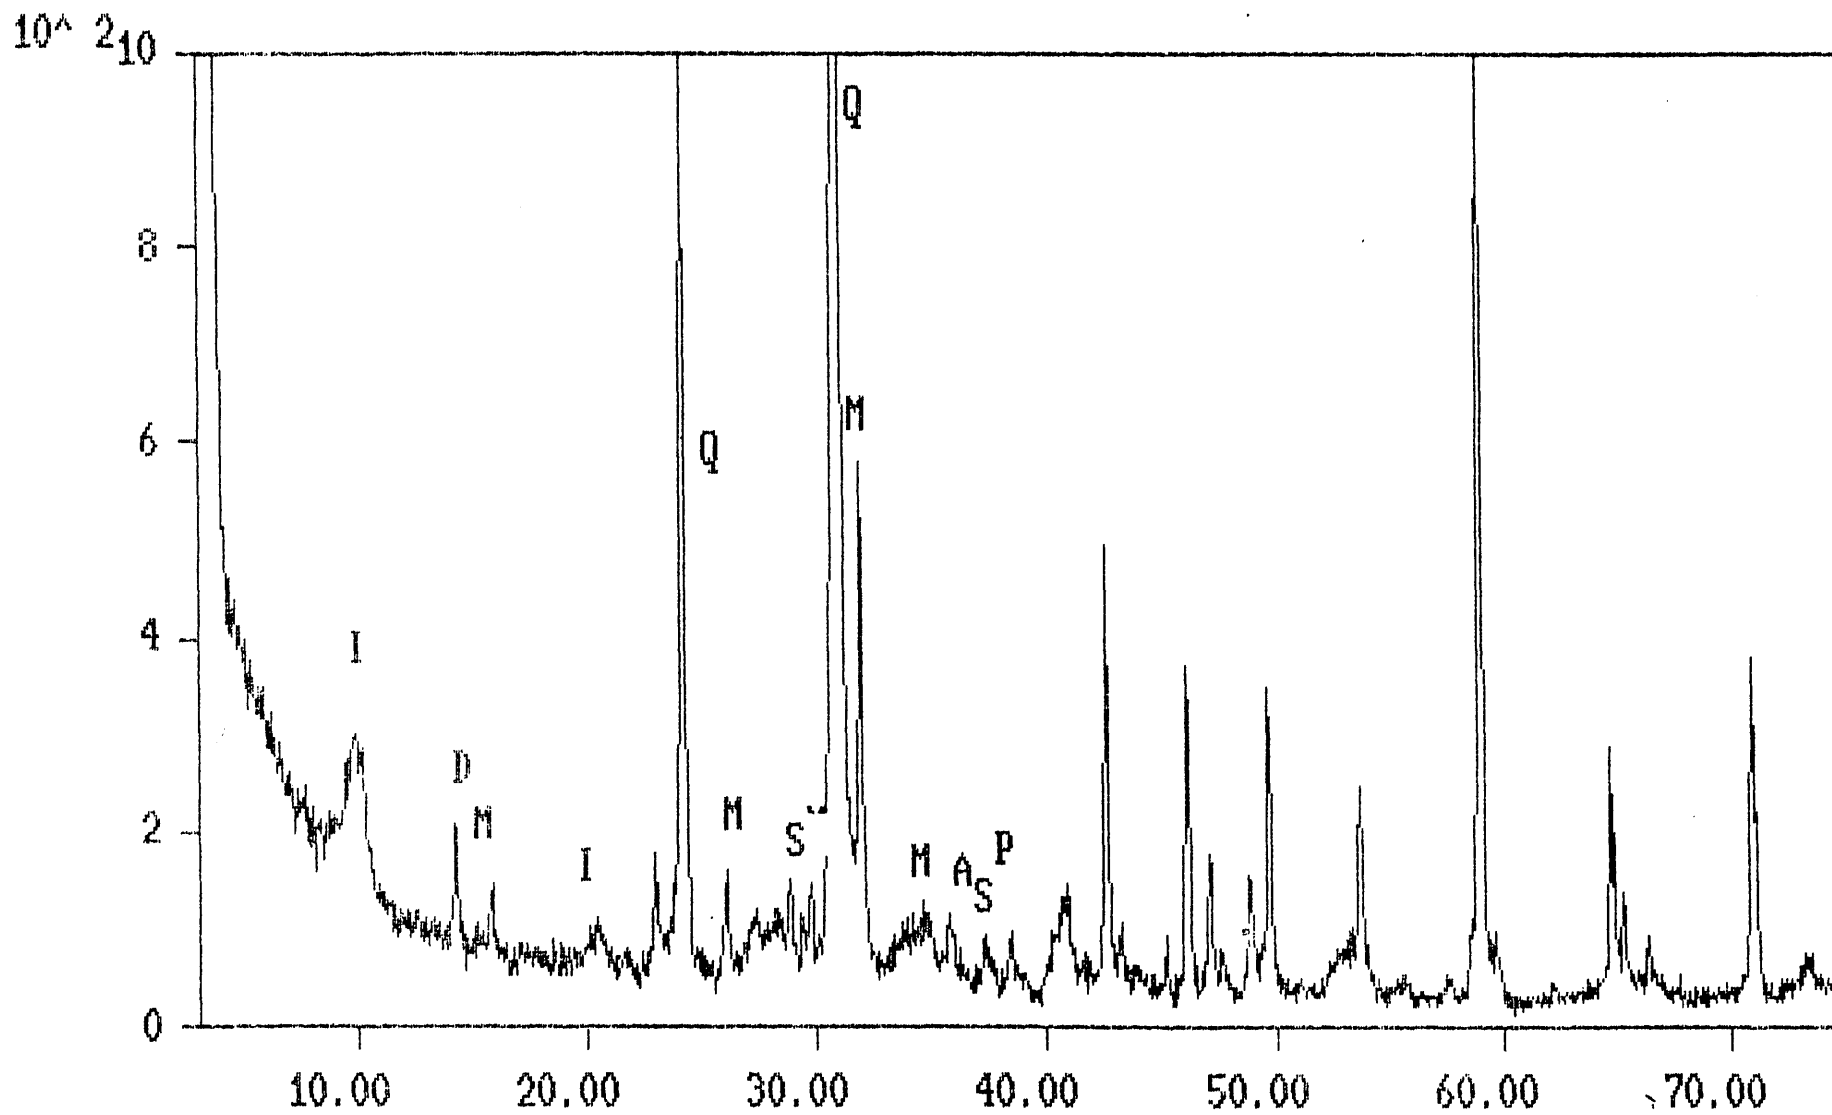
Figure 20. Bulk XRD trace of Anemone #1A, junk sub sample, 4676b m. Q=quartz, I=illite/muscovite, D=dickite, M=microcline, P=pyrite, S=siderite and A=ankerite. Only the strongest peaks have been labelled for each mineral.

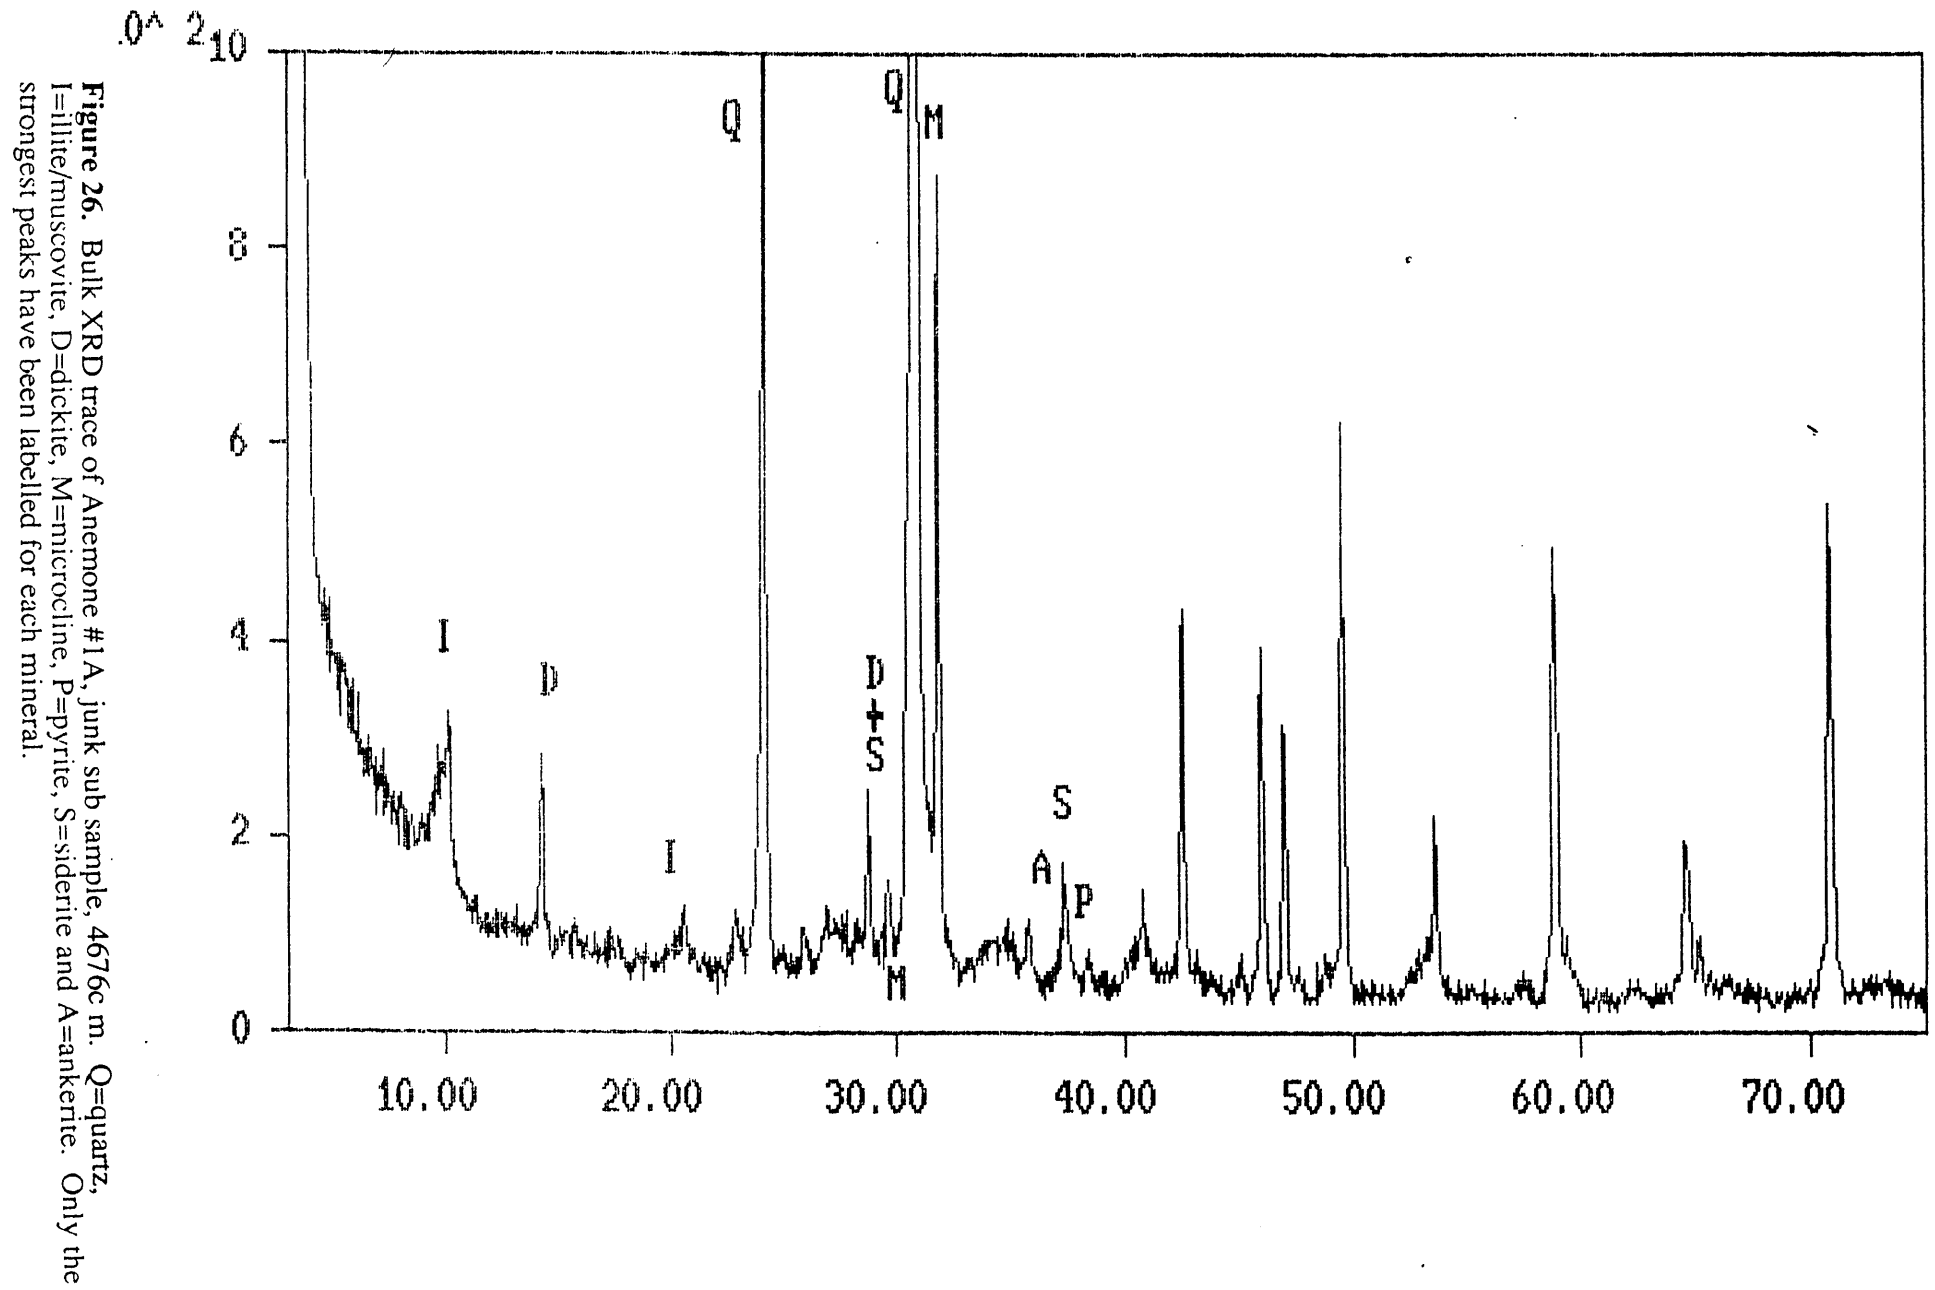
Figure 26. Bulk XRD trace of Anemone #1A, junk sub sample, 4676c m. Q=quartz, I=illite/muscovite, D=dickite, M=microcline, P=pyrite, S=siderite and A=ankerite. Only the strongest peaks have been labelled for each mineral.

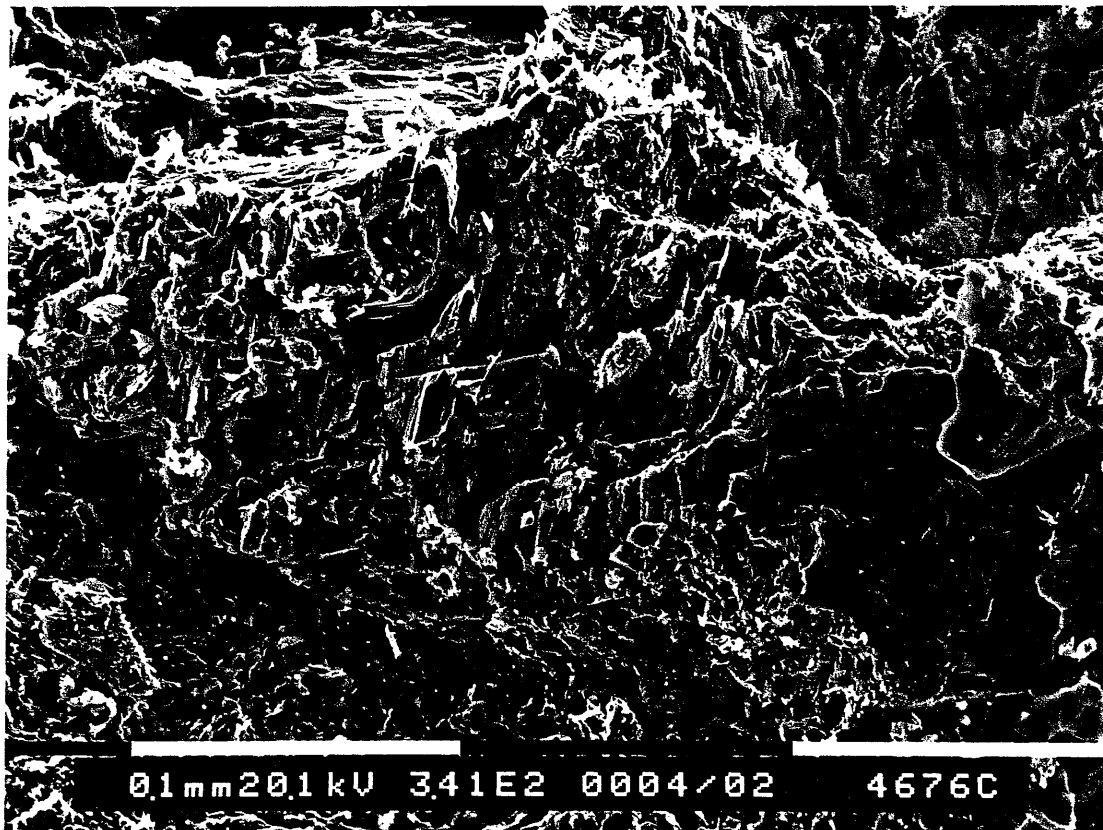
Figure 27 - Anemone #1A, junk sub sample, 4676c m. Scanning electron micrograph showing general view of sediment with abundant clay matrix and probable drilling mud. No porosity is evident. Rare euhedral quartz overgrowths are evident from straight faces on quartz grains.

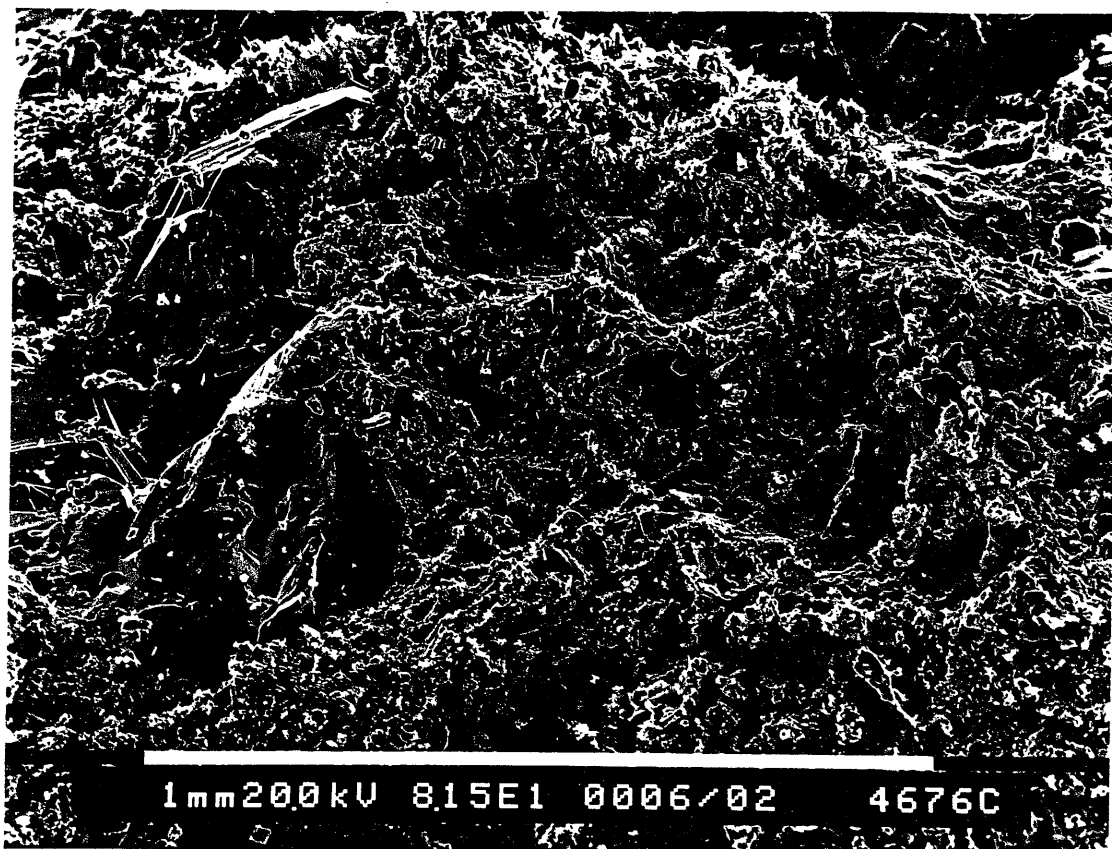
Figure 28 - Anemone #1A, junk sub sample, 4676c m. Scanning electron micrograph demonstrating dissolution of K feldspar along preferred crystallographic axes. Eventually this dissolution will lead to the development of secondary porosity.

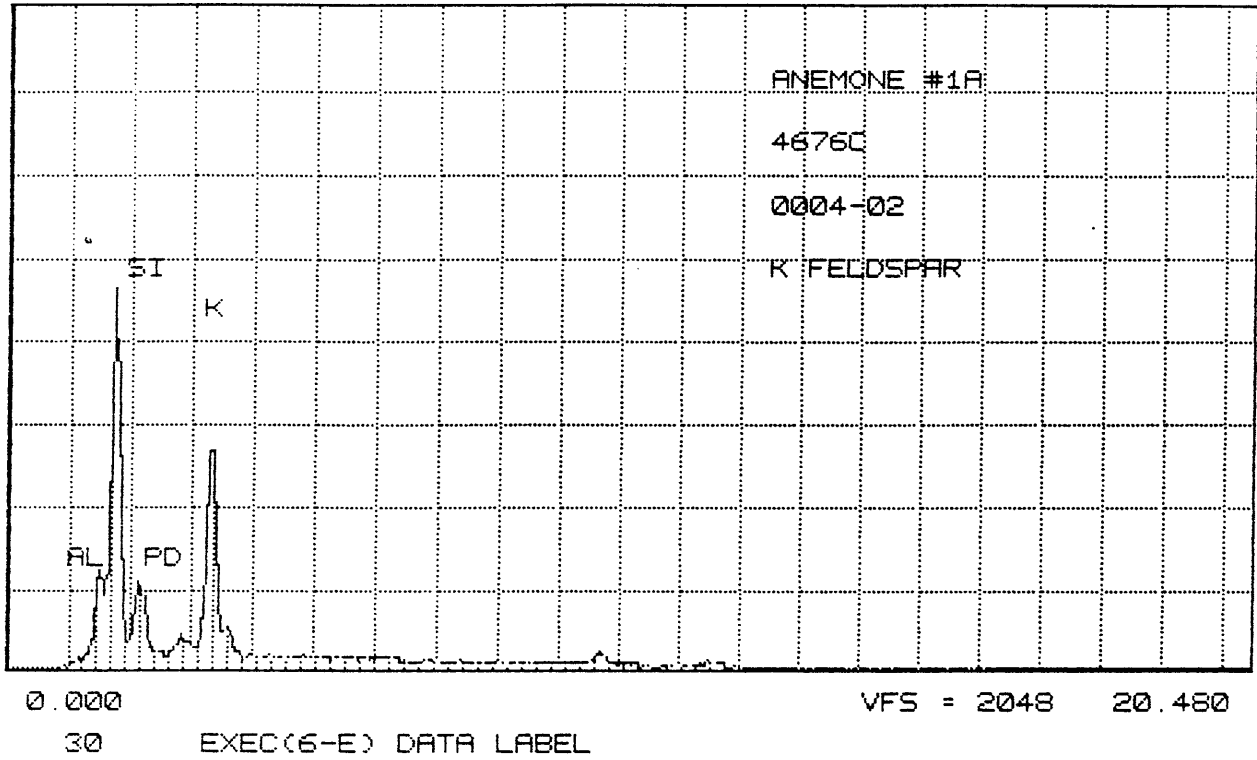
Figure 29. Anemone #1A, junk sub sample, 4676c metres. EDS pattern of K feldspar from previous figure.

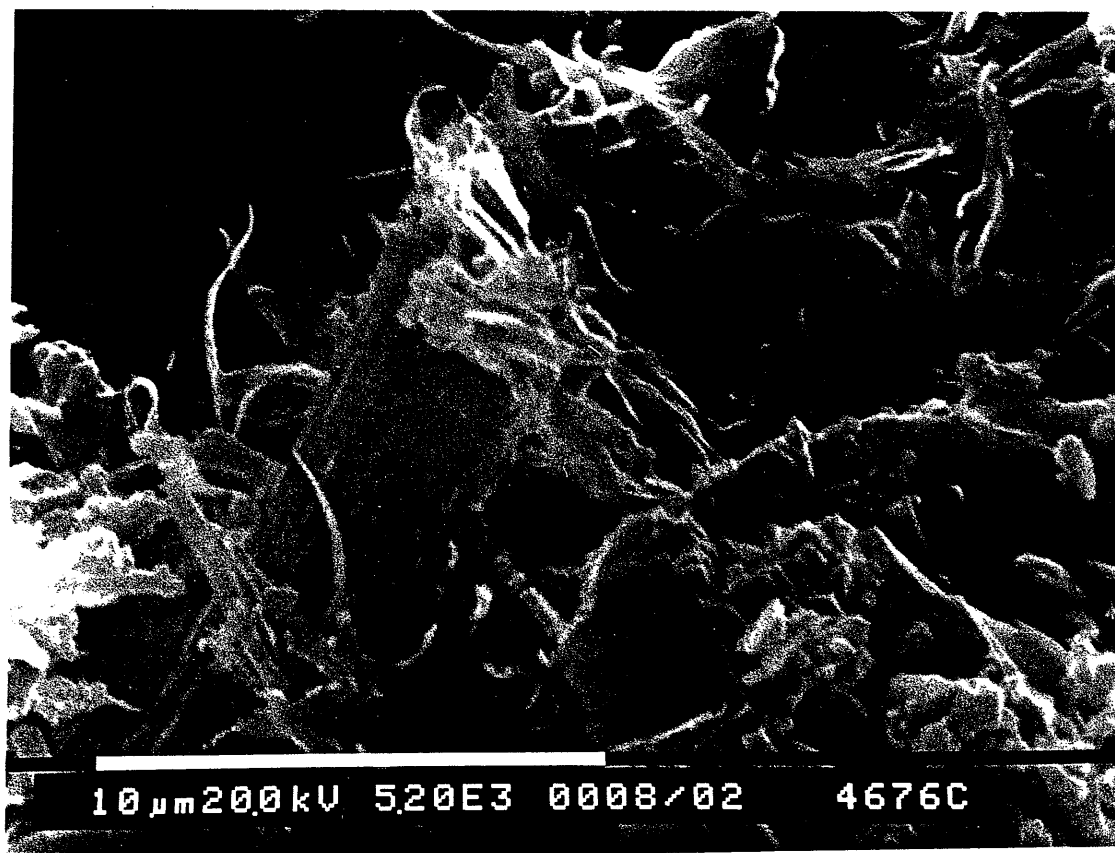
Figure 30 - Anemone #1A, junk sub sample, 4676c m. Long, unbroken fibres of illite suggest its authigenic origin.

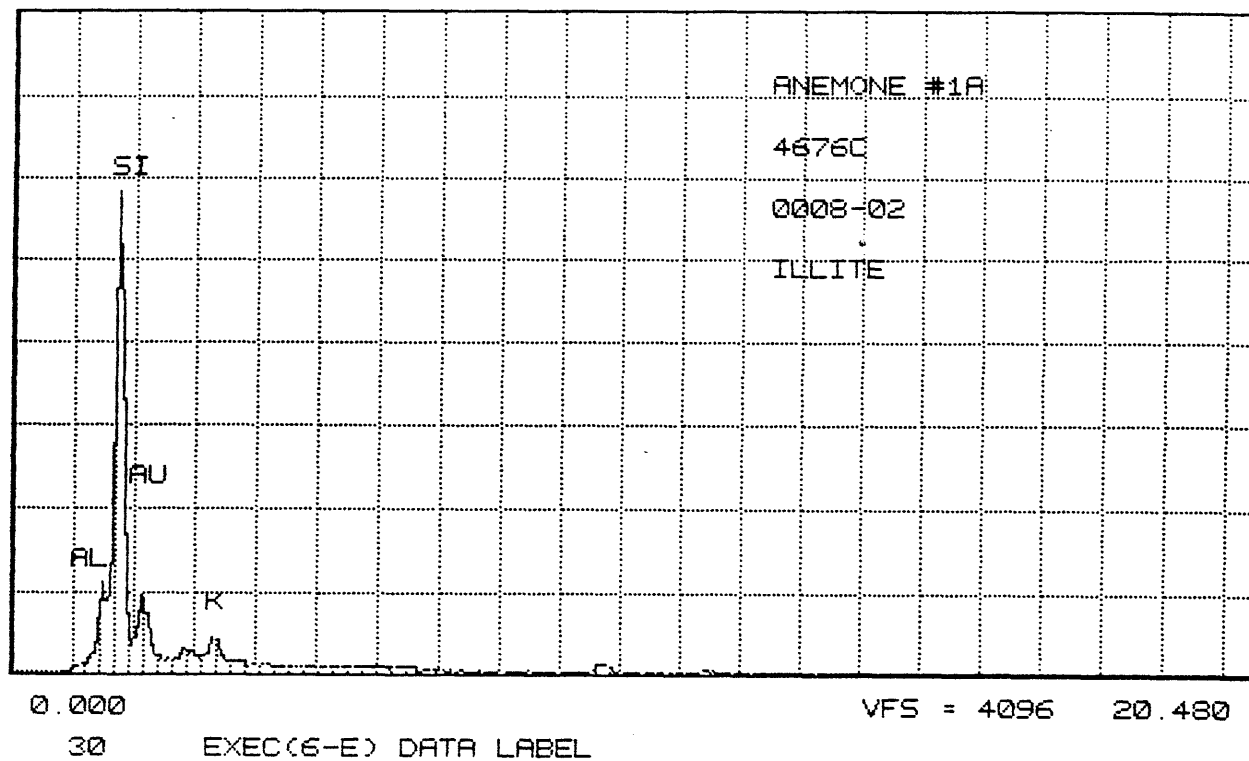
Figure 31. Anemone #1A, junk sub sample, 4676c metres. EDS pattern of illite from the previous figure.

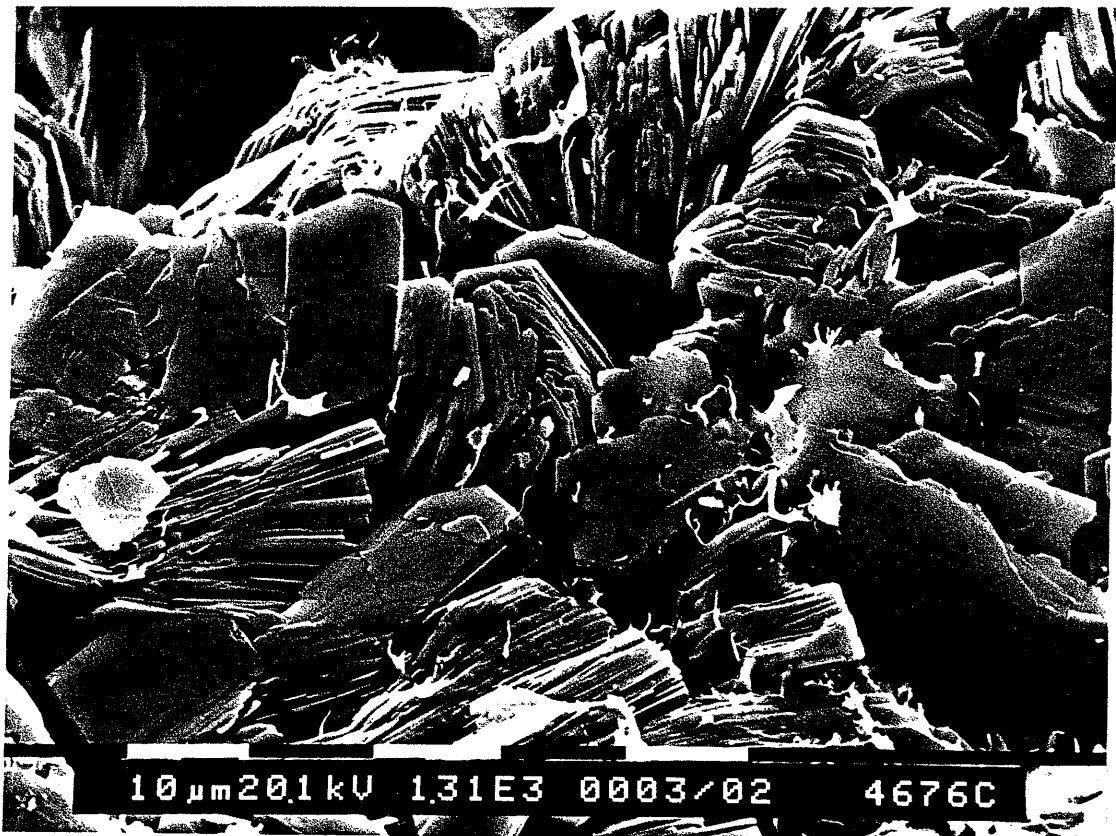
Figure 32 - Anemone #1A, junk sub sample, 4676c m. Detail of euhedral pseudo-hexagonal kaolin booklets that suggest an authigenic origin. Associated microporosity and permeability are partially restricted by fibrous illite.
