**PETROGRAPHIC ANALYSIS  
REPORT**

**ANEMONE 1 & 1A**

PETROGRAPHIC ANALYSIS REPORT

**ANEMONE #1, #1A**

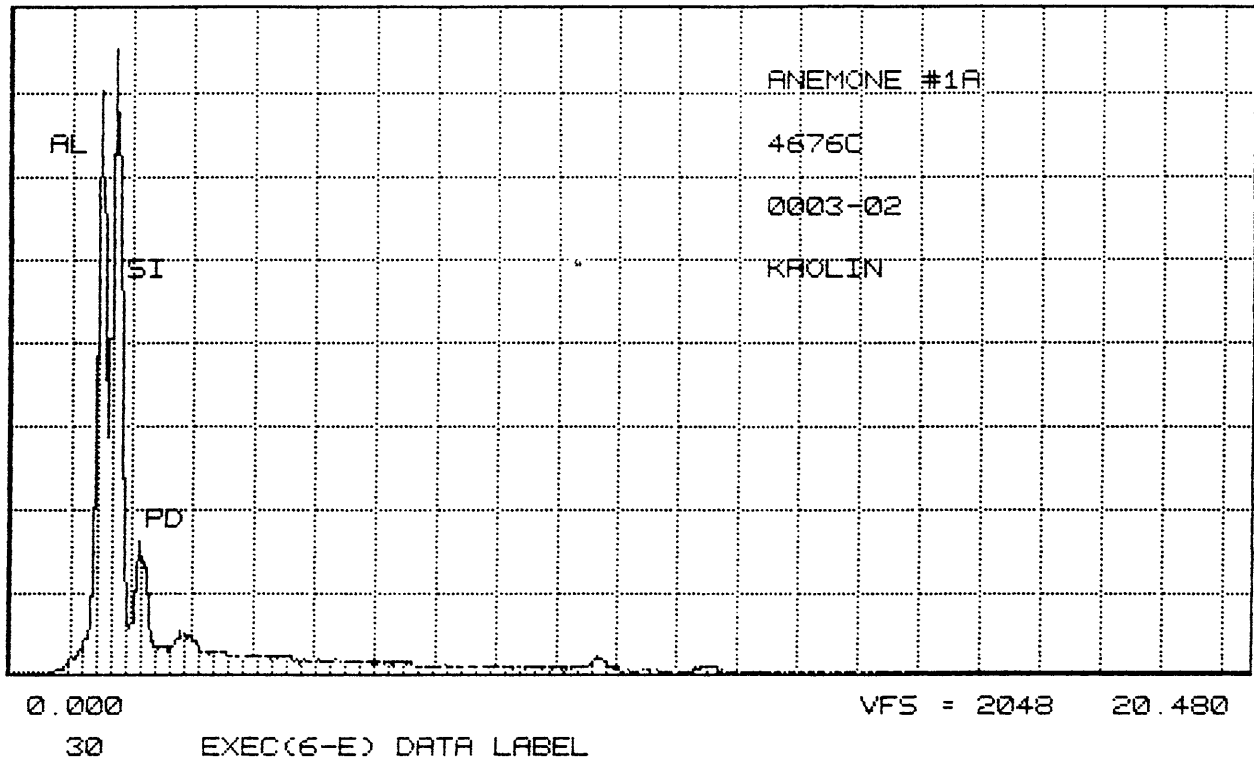
Figure 33. Anemone #1A, junk sub sample, 4676c metres. EDS pattern of kaolin from the previous figure.

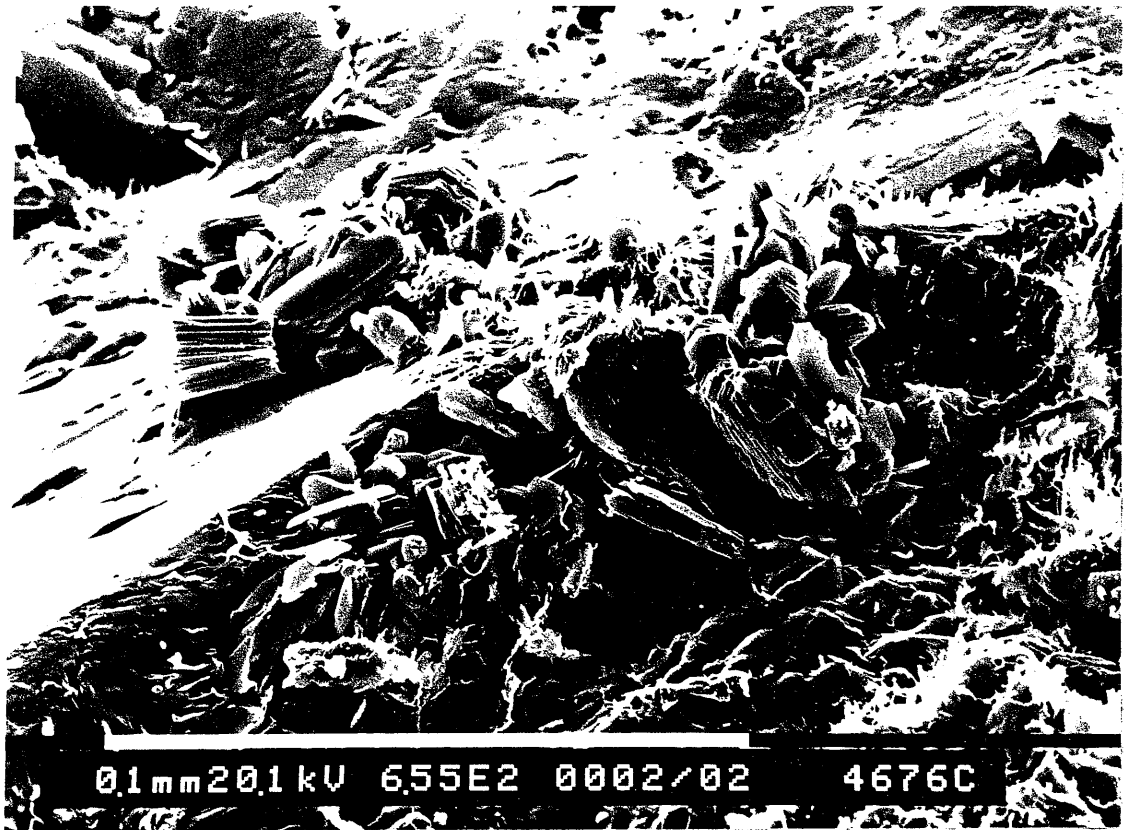
Figure 34 - Anemone #1A, junk sub sample, 4676c m. Scanning electron micrograph showing kaolin booklets overlying an unaltered K feldspar grain. Wisps of authigenic illite are scattered over the surface of the feldspar and kaolin.

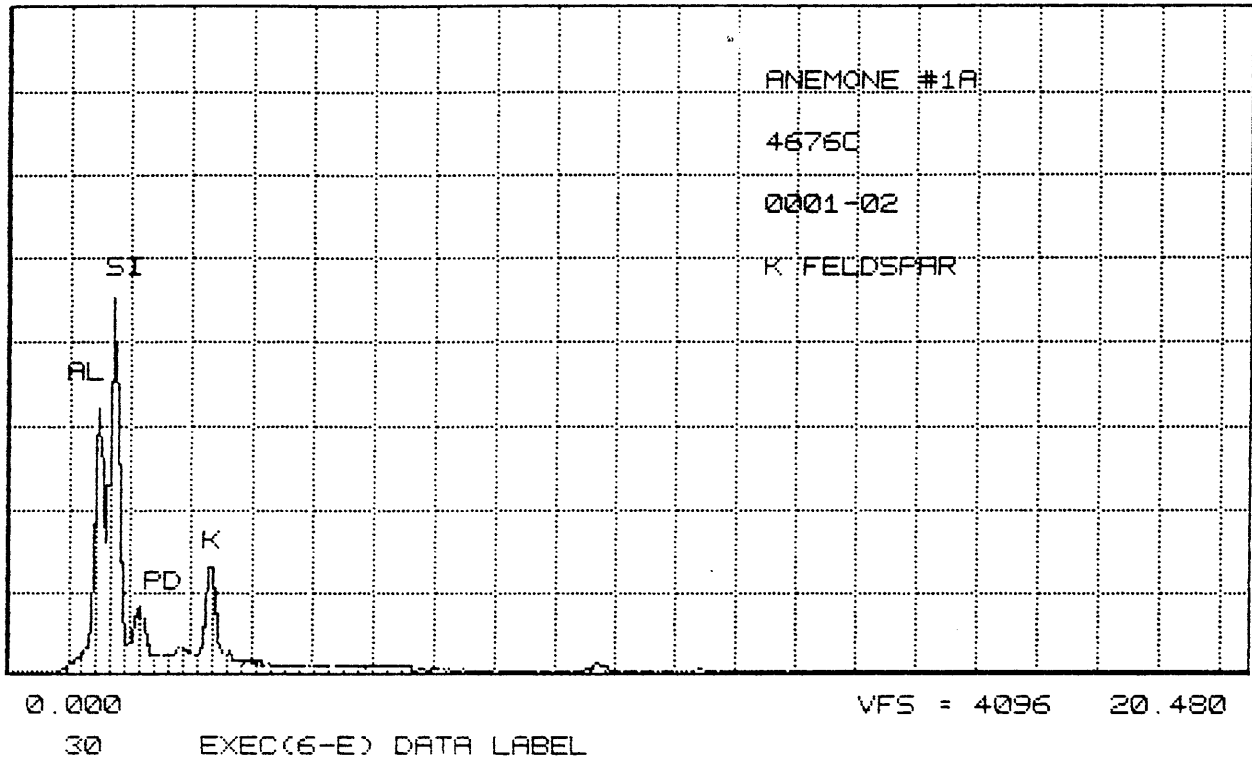
Figure 35. Anemone #1A, junk sub sample, 4676c metres. EDS pattern of K feldspar from previous figure.

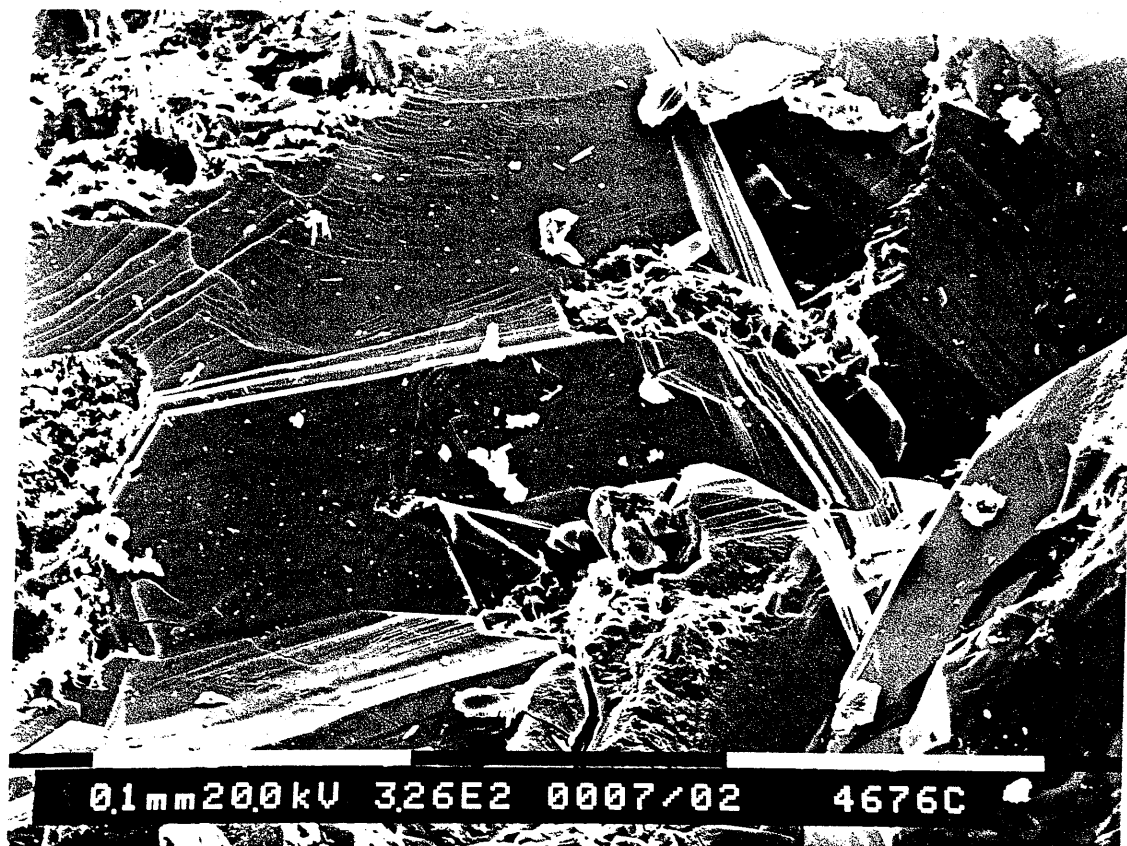
Figure 36, Anemone #1A, junk sub sample, 4676c m. Euhedral quartz overgrowths have reduced primary porosity. Step fracturing of quartz due to sample preparation is evident. Note that the presence of illite has limited the development of overgrowths in some zones.

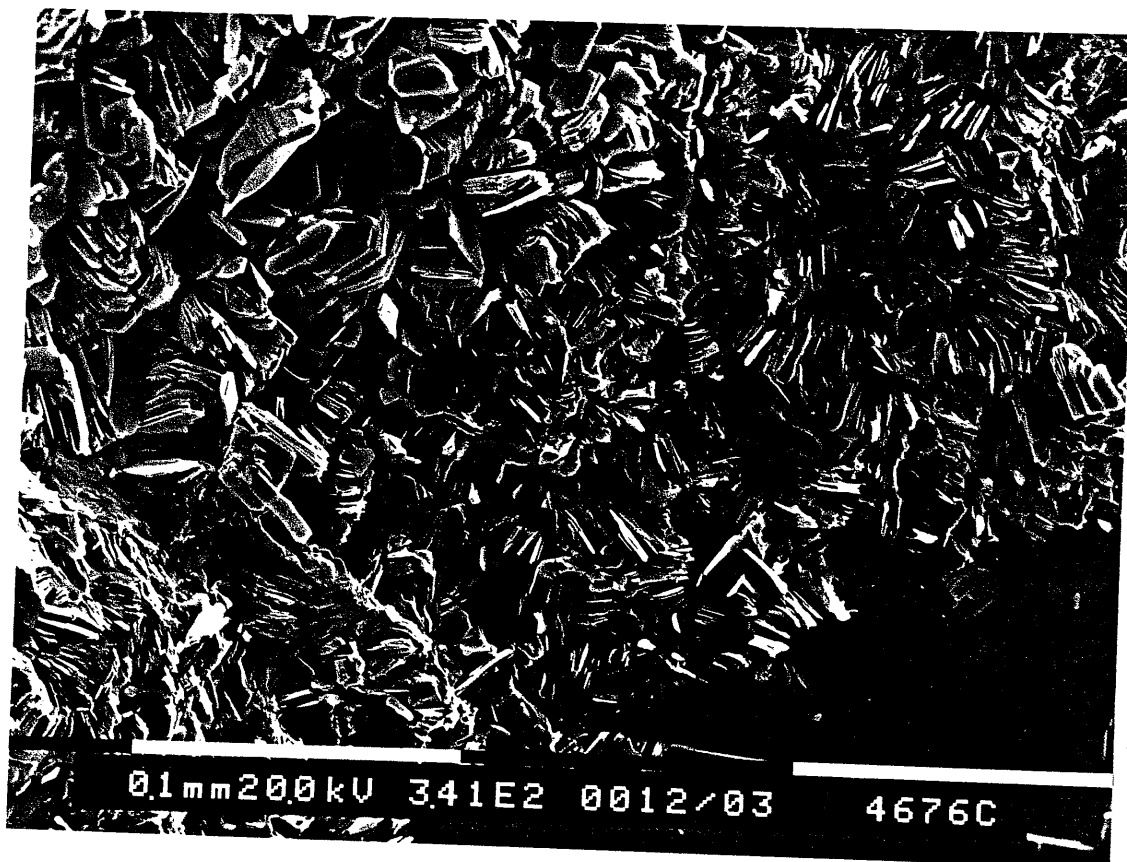
Figure 37 - Anemone #1A, junk sub sample, 4676c m.  
Scanning electron micrograph demonstrating a very broad zone of  
intergrowth between kaolin booklets and authigenic quartz (Q).

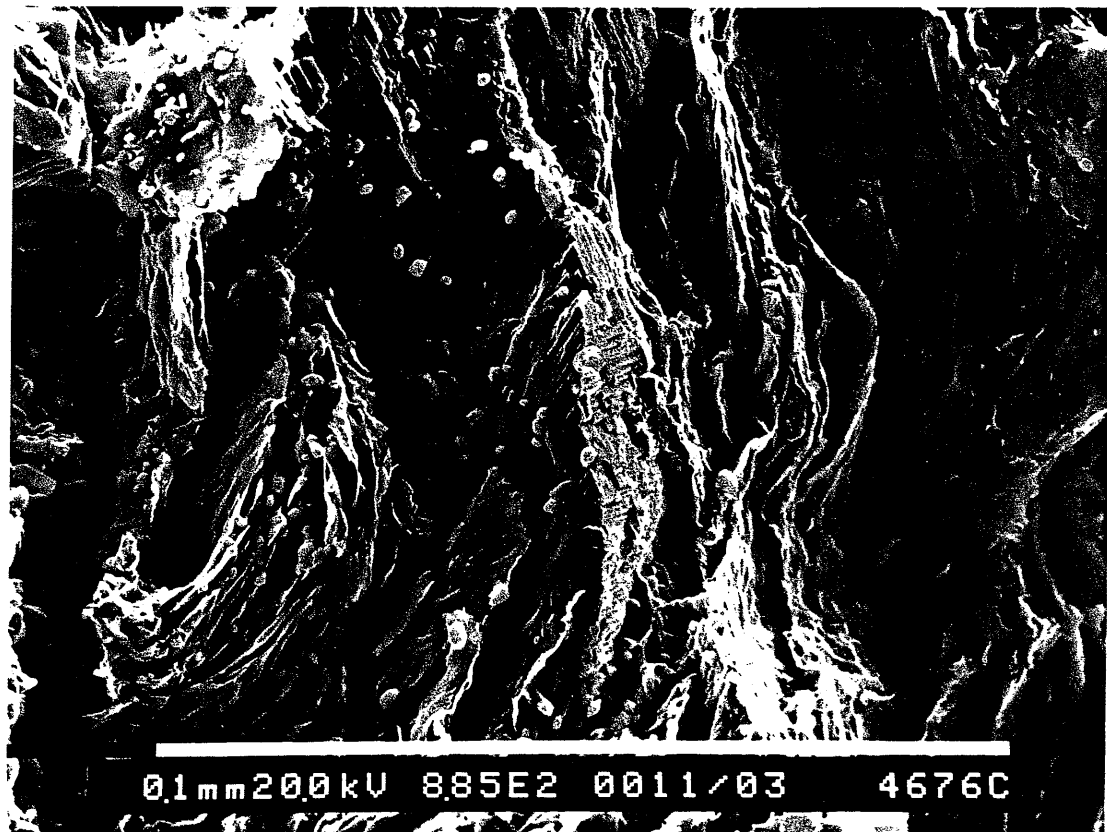
Figure 38 - Anemone #1A, junk sub sample, 4676c m. SEM micrograph shows a subhedral siderite rhomb (S) is intergrown along cleavage of a biotite fragment. The small white crystals are drilling mud contaminants.

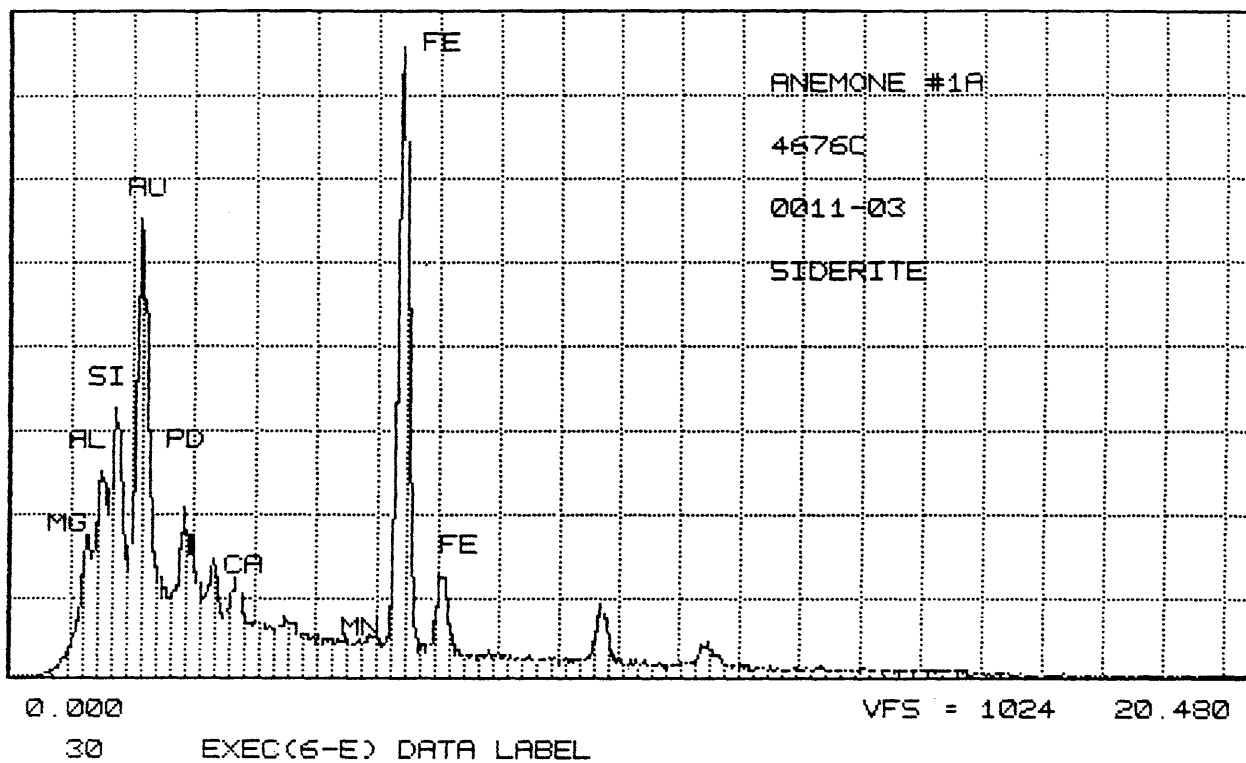
Figure 39. Anemone #1A, junk sub sample, 4676c metres. EDS pattern of siderite from the previous figure.

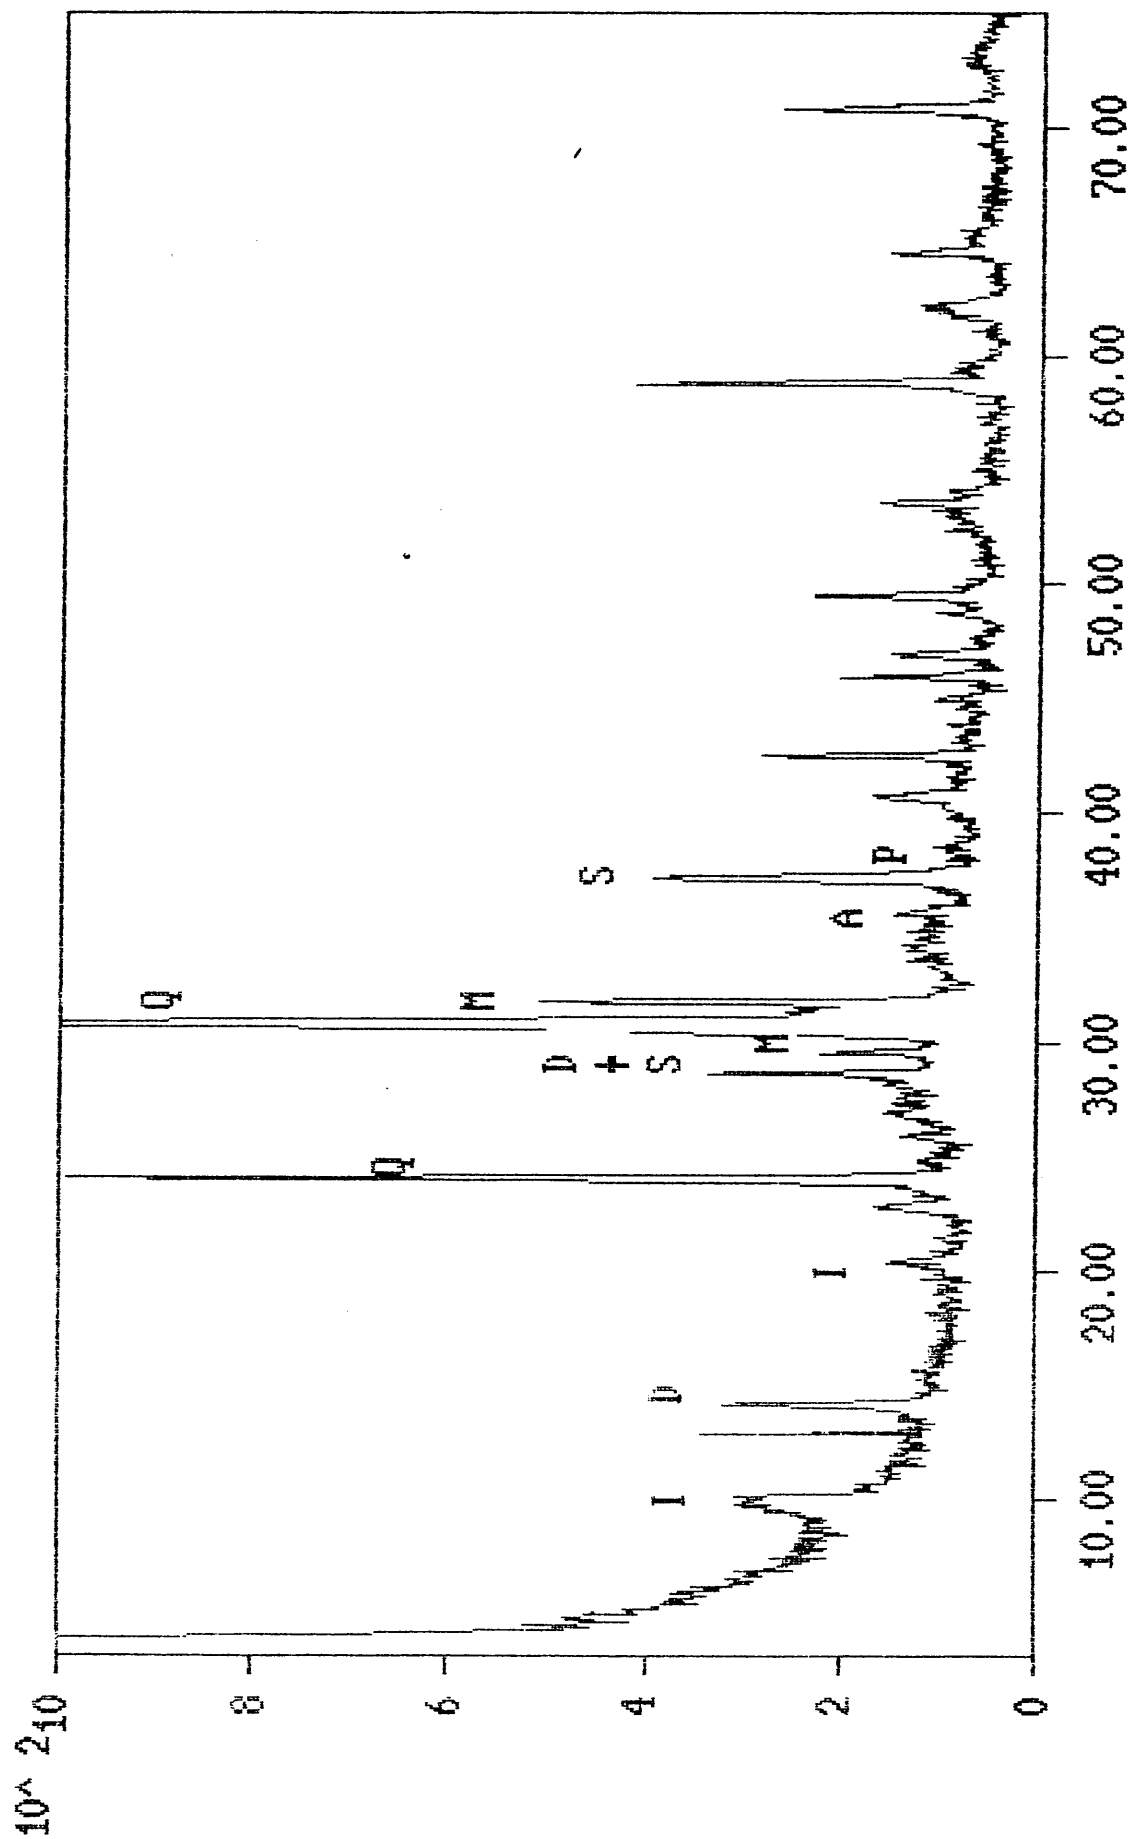
Figure 44. Bulk XRD trace of Anemone #1A, junk sub sample, 4676d m. Q=quartz, I=illite/muscovite, D=dickite, M=microcline, P=pyrite, S=siderite and A=ankerite. Only the strongest peaks have been labelled for each mineral.

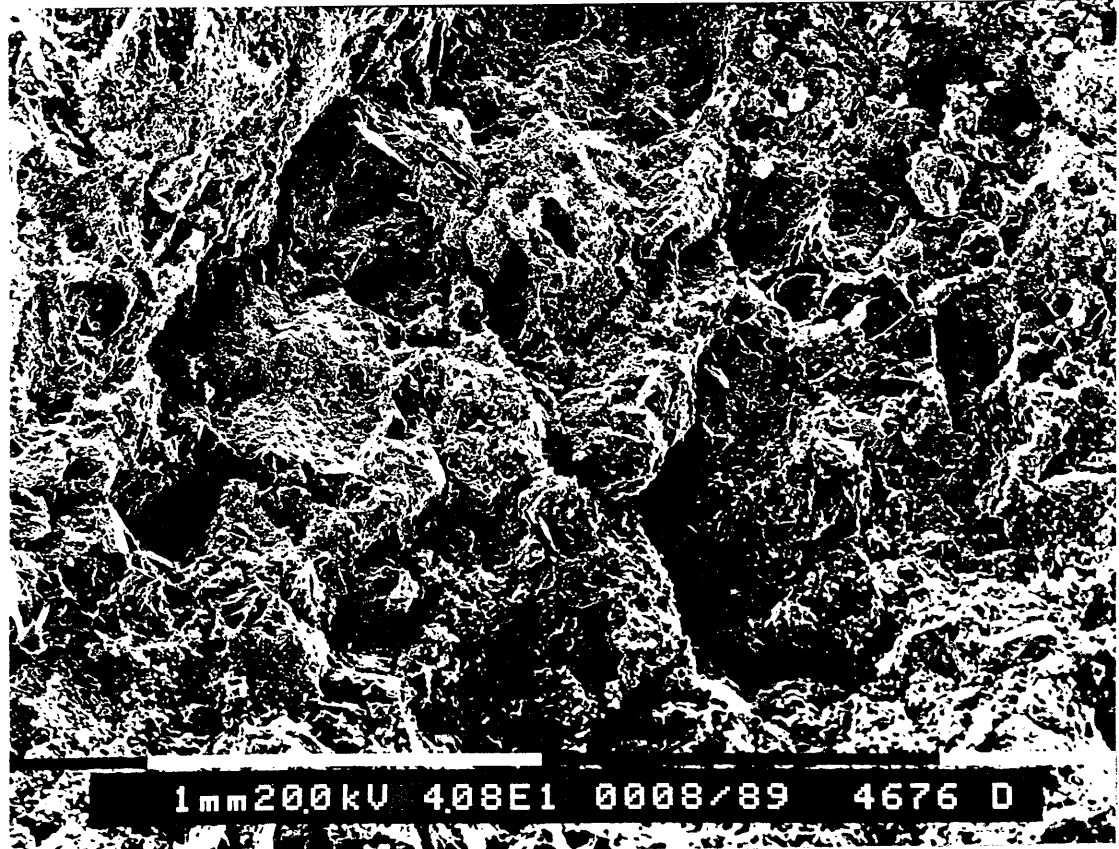
Figure 45 - Anemone #1A, junk sub sample, 4676d m. Scanning electron micrograph showing general view of sediment with abundant clay, including drilling mud. There is only minor porosity evident. Pores are of hybrid primary-secondary origin, since pore sizes are comparable to, or slightly larger than the average grain size. They may have resulted from whole grain dissolution.

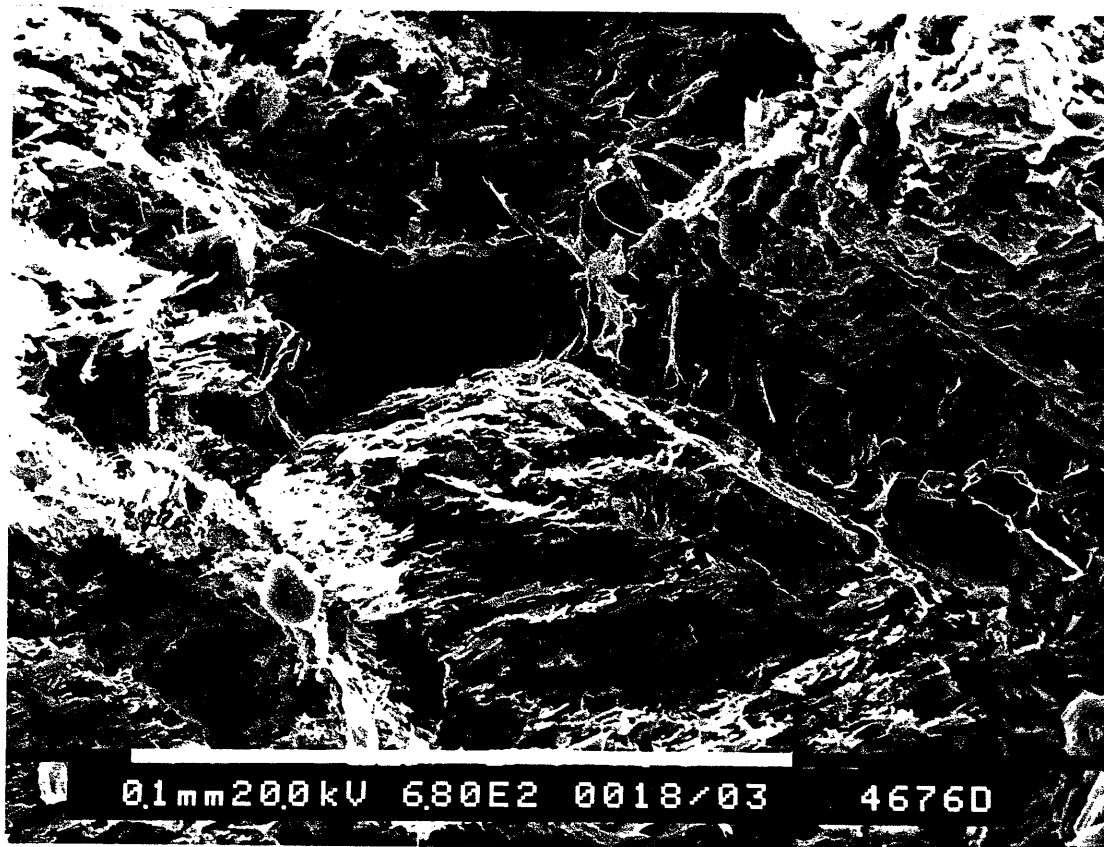
Figure 46, Anemone #1A, junk sub sample, 4676d m. Scanning electron micrograph demonstrating partial occlusion of pore throats by fibrous authigenic illite between dissolving feldspars. While it does not reduce porosity significantly, this type of bridging will create significant permeability barriers to flow.

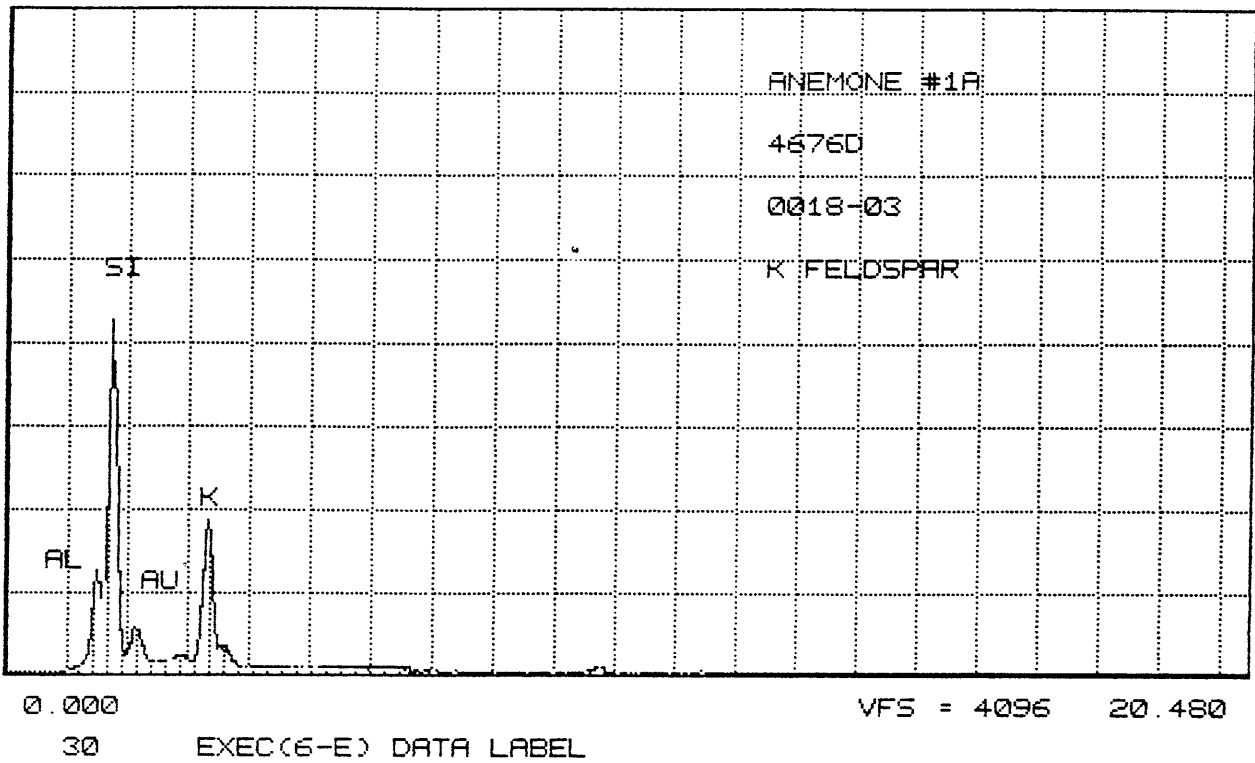
Figure 47. Anemone #1A, junk sub sample, 4676d metres. EDS pattern of K feldspar from previous figure.

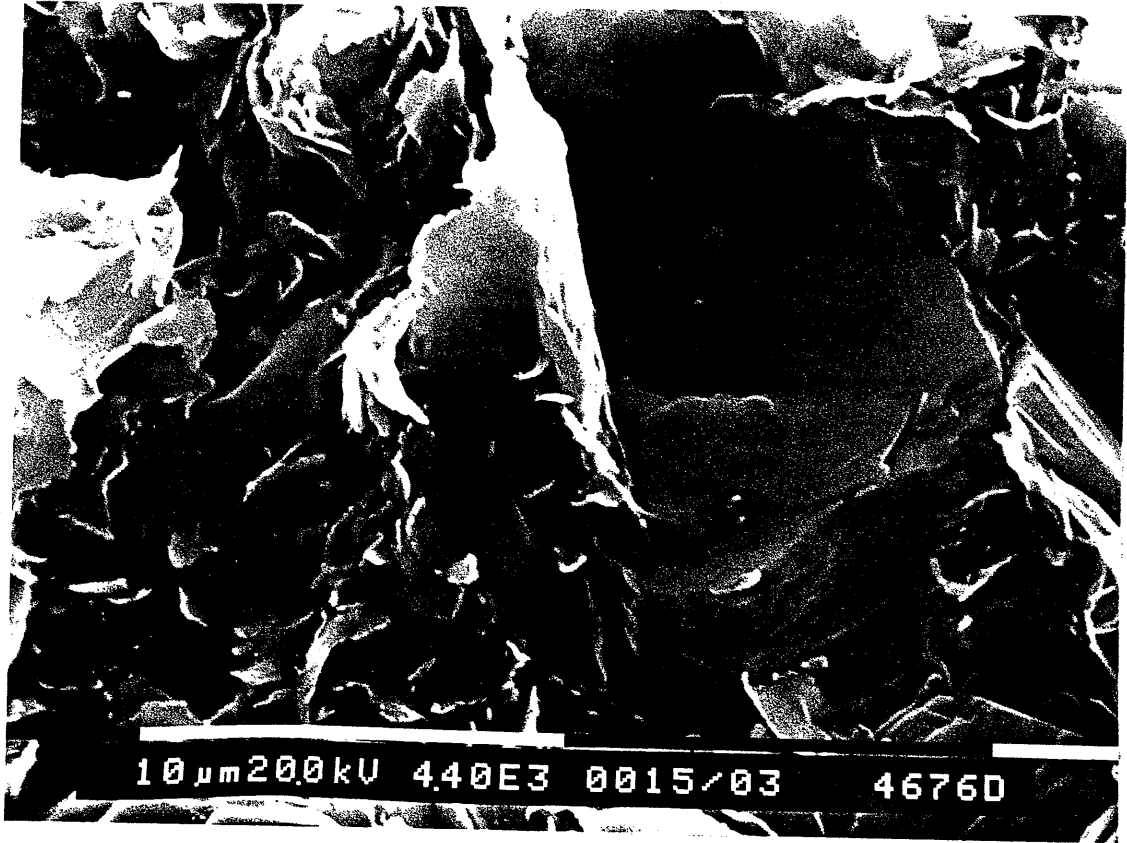
Figure 48 - Anemone #1A, junk sub sample, 4676d m. Scanning electron micrograph showing detail of intergrowth of kaolin platelets and fibrous illite.

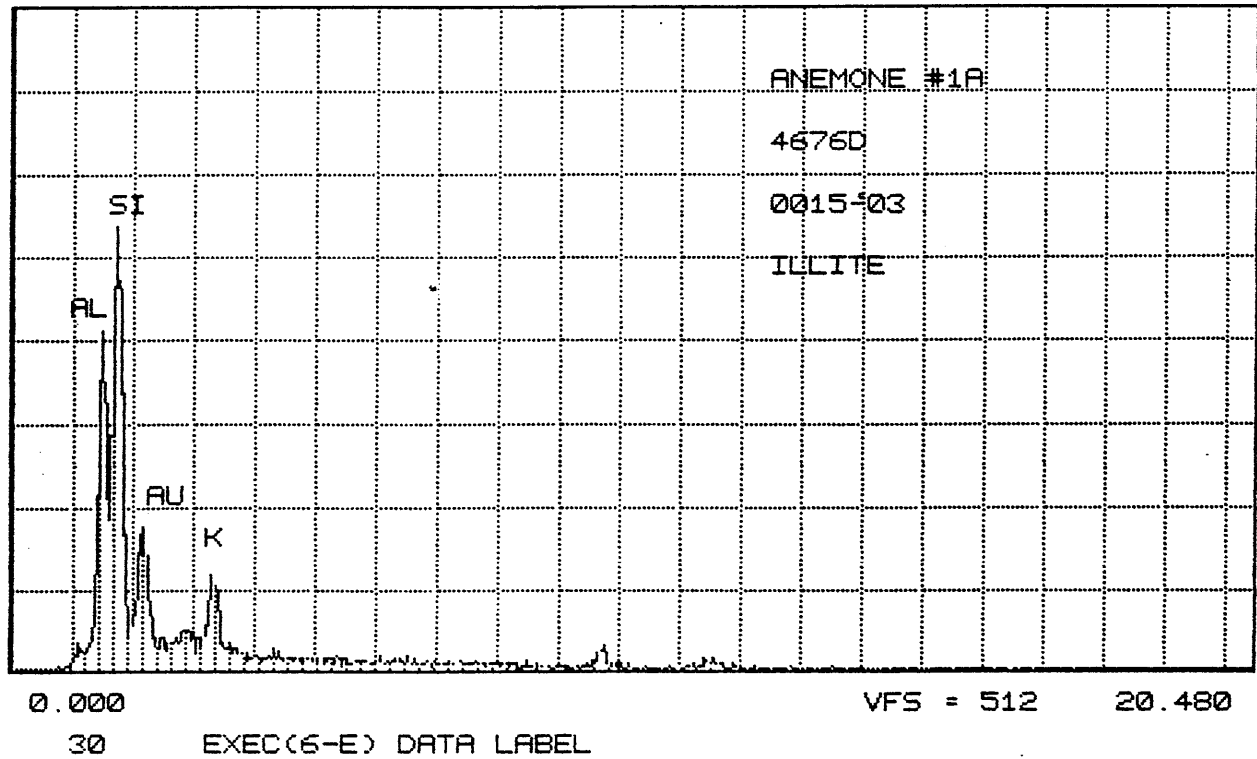
Figure 49. Anemone #1A, junk sub sample, 4676d metres. EDS pattern of illite from the previous figure.

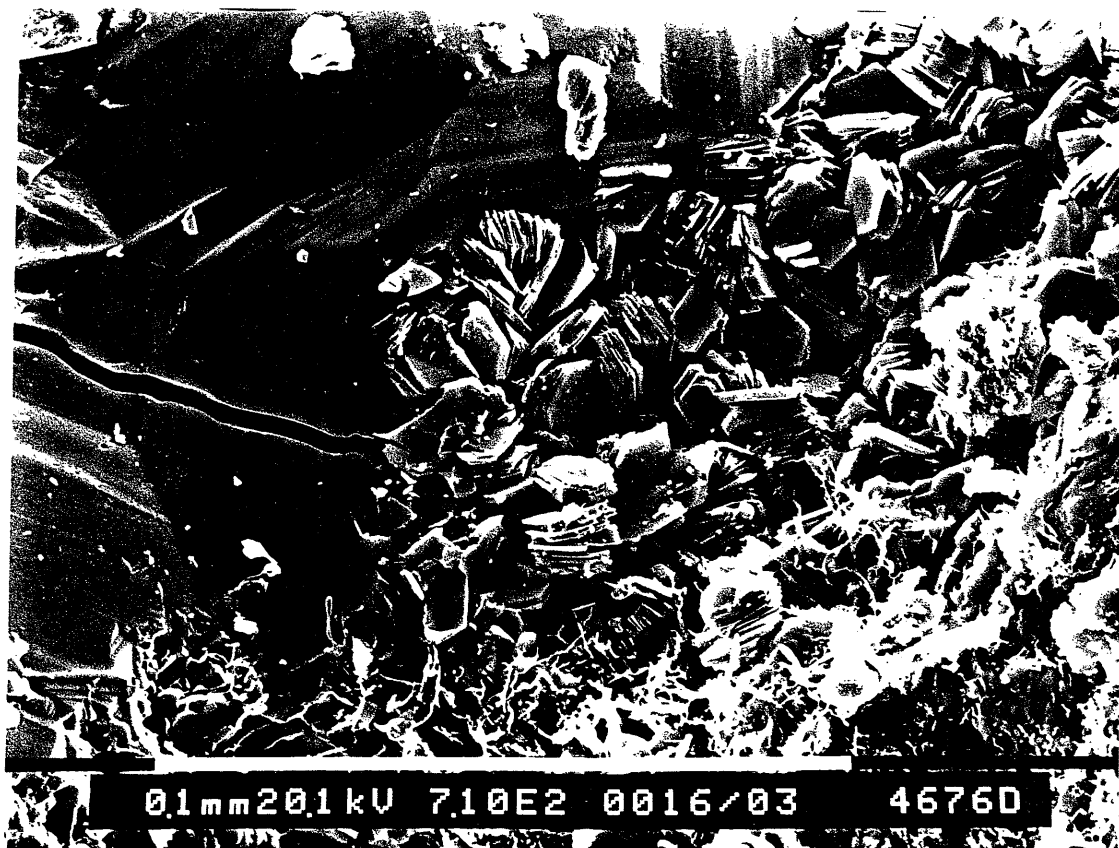
Figure 50 - Anemone #1A, junk sub sample, 4676d m. Kaolin booklets lie adjacent to fractured quartz (q) and show intergrowth at the contact. Platy and fibrous illite is apparent in the lower right of the micrograph.

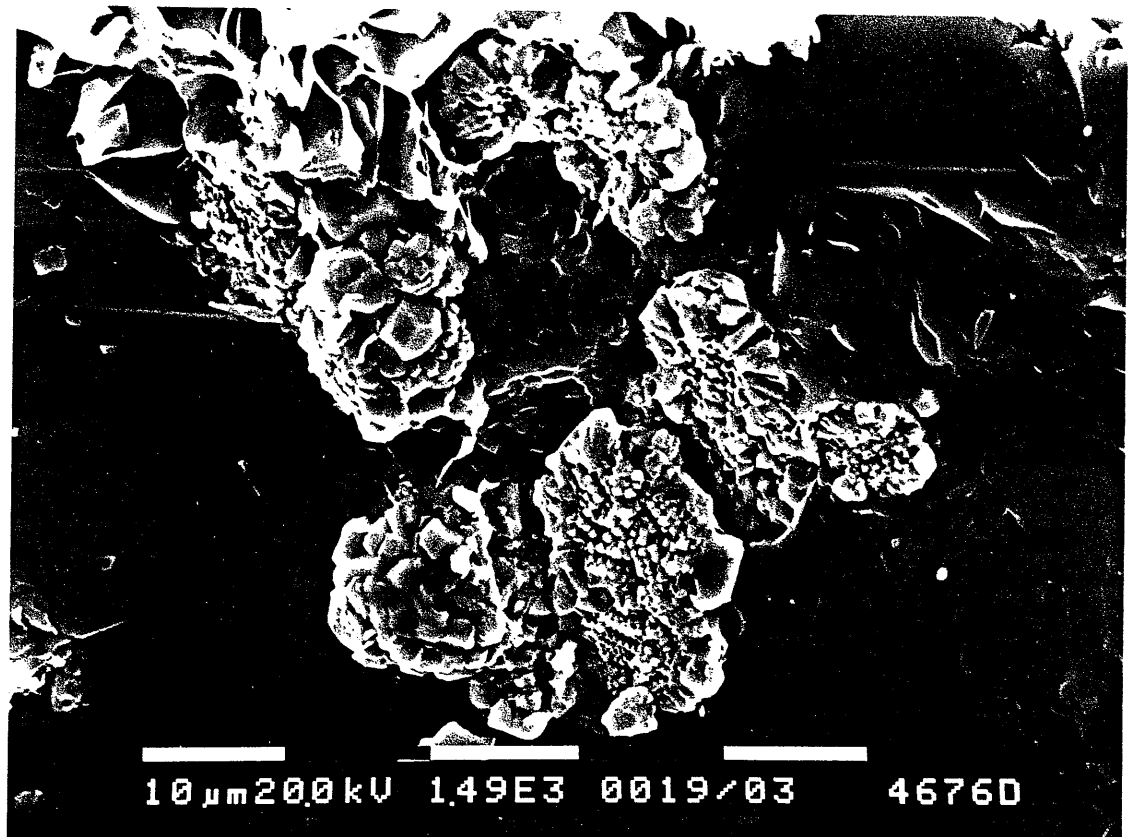
Figure 51 - Anemone #1A, junk sub sample, 4676d m. Pyritic aggregates which have been engulfed by authigenic quartz. An early, fine crystal phase and a later coarse crystal phase of pyrite growth are evident. Moulds in the quartz indicate that some pyrite has probably been plucked during sample preparation.

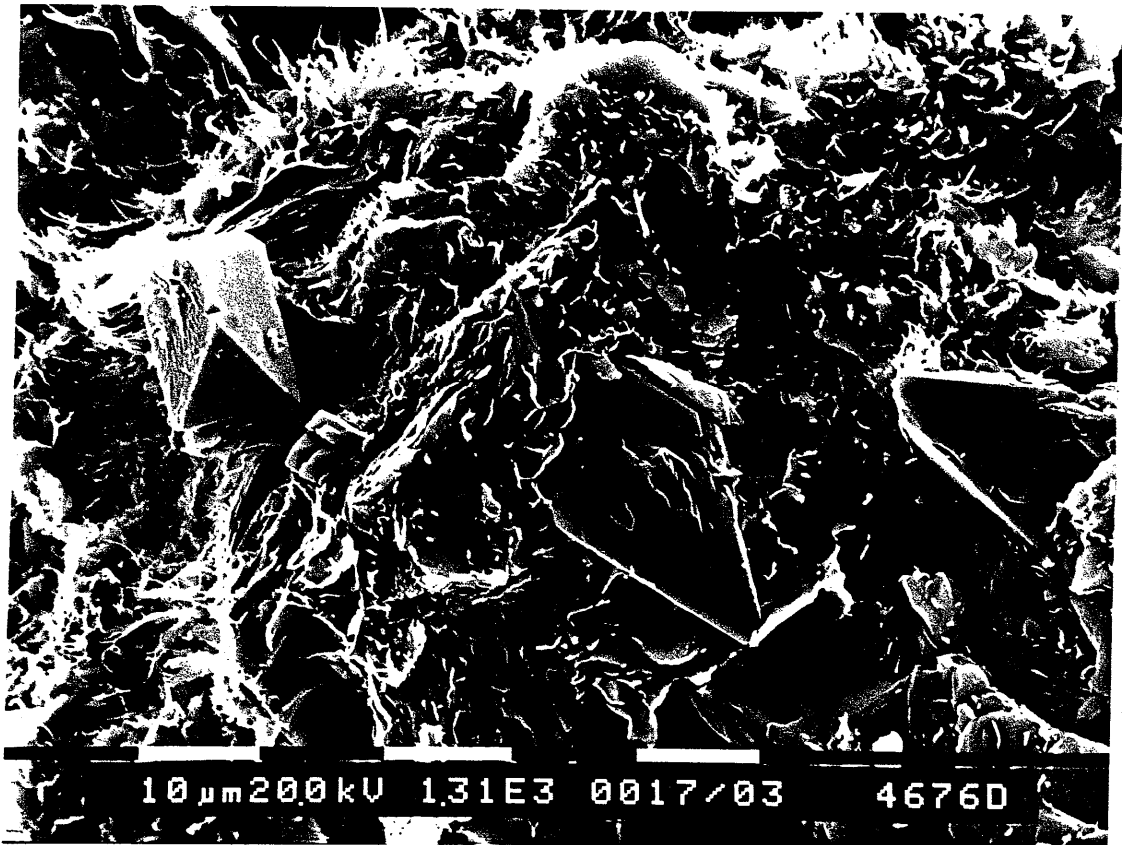
Figure 52 - Anemone #1A, junk sub sample, 4676d. Scanning electron micrograph showing euhedral anatase crystals (An) of authigenic origin.

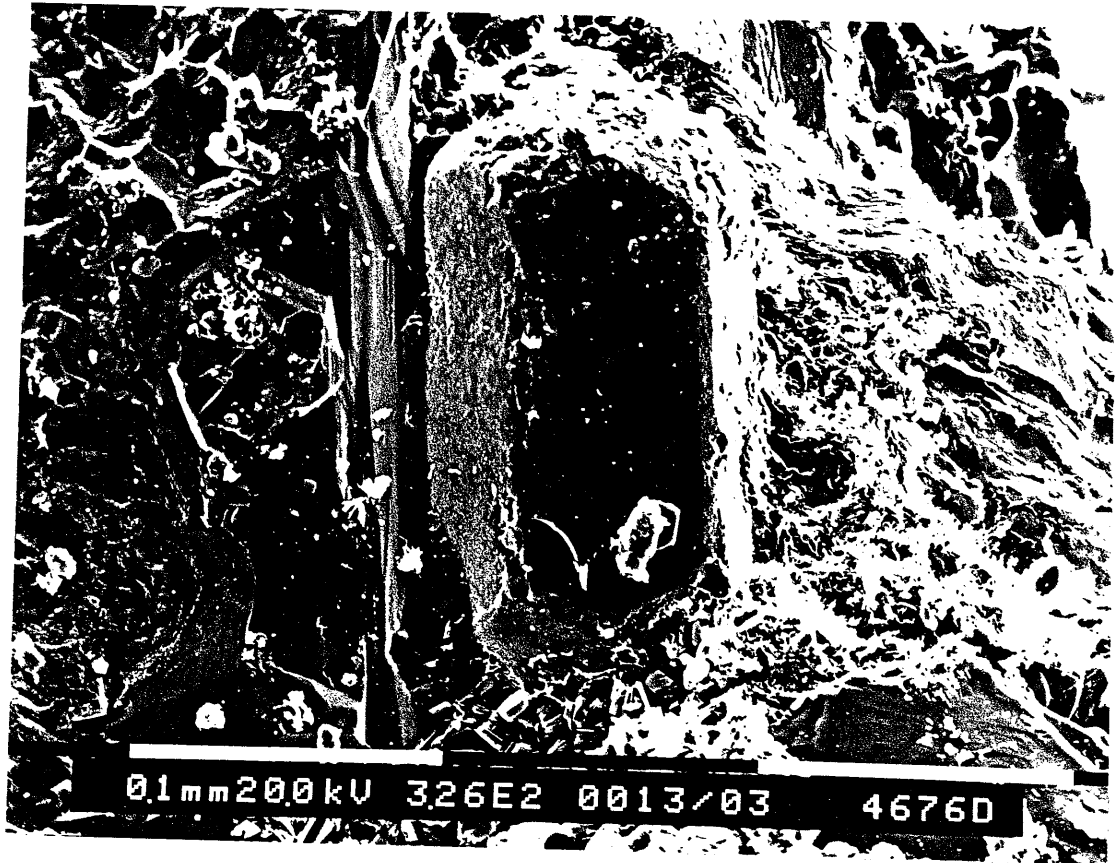
Figure 53, Anemone #1A, junk sub sample, 4676d m. A subhedral apatite crystal surrounded by clay matrix to the right and euhedral quartz to the left. Slight rounding of the crystal reflects it's detrital origin.

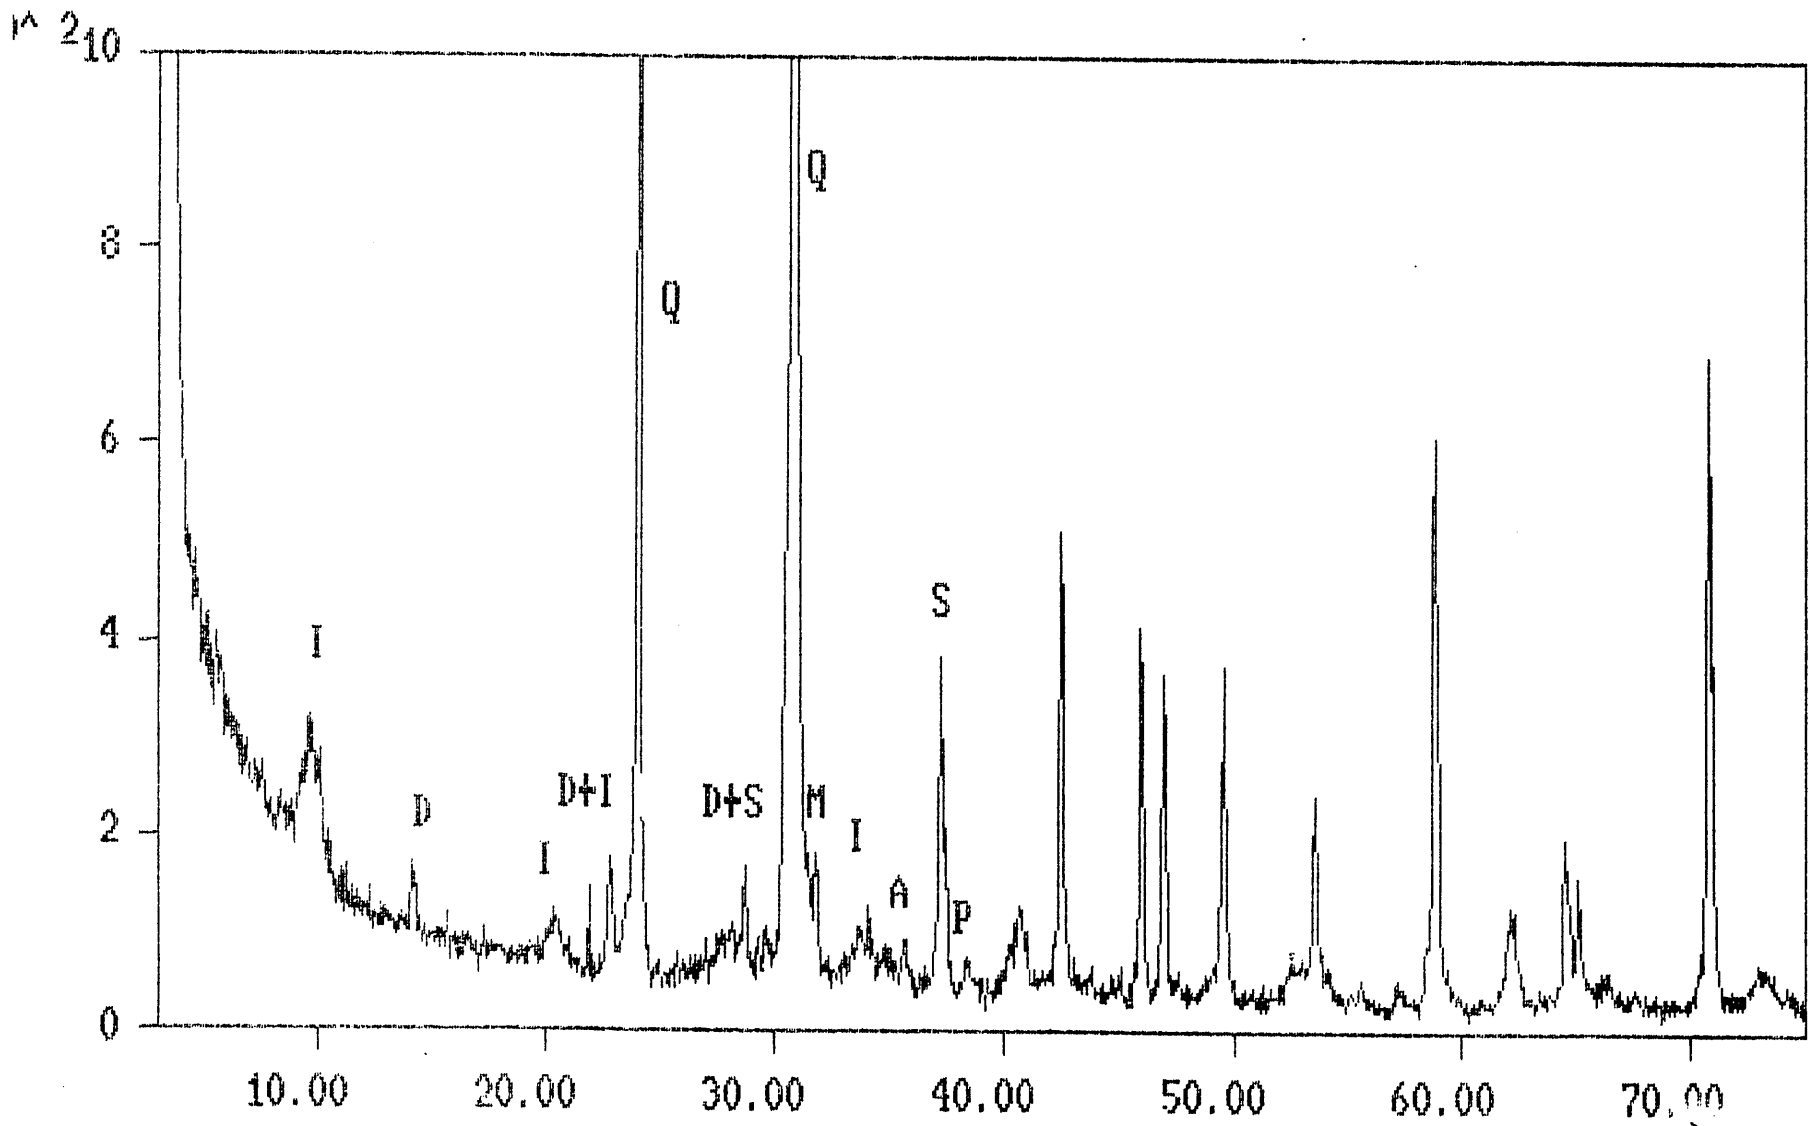
Figure 65. Bulk XRD trace of Anemone #1A, junk sub sample, 4676f m. Q=quartz, I=illite/muscovite, D=dickite, M=microcline, P=pyrite, S=siderite and A=ankerite. Only the strongest peaks have been labelled for each mineral.

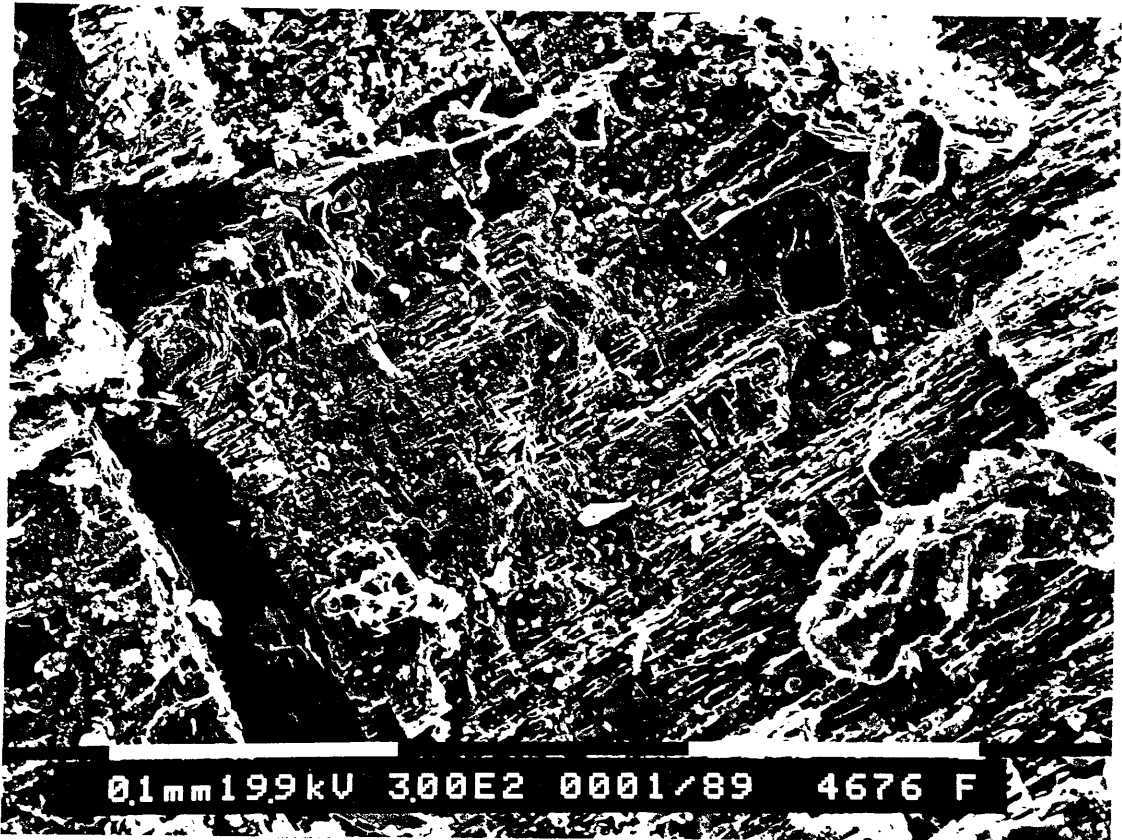
Figure 67 - Anemone #1A, junk sub sample, 4676f m. A SEM micrograph showing dissolution of K feldspar has produced minor secondary porosity.

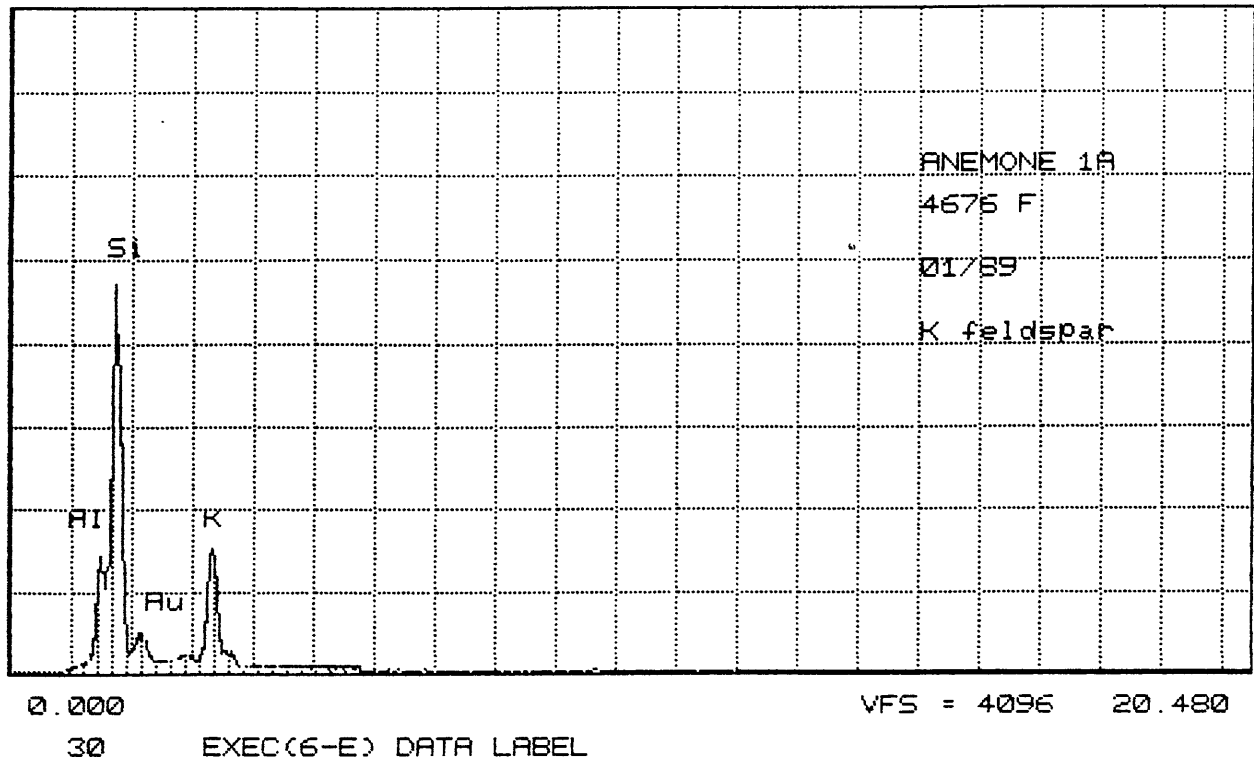
Figure 68. Anemone #1A, junk sub sample, 4676f metres. EDS pattern of K feldspar from previous figure.

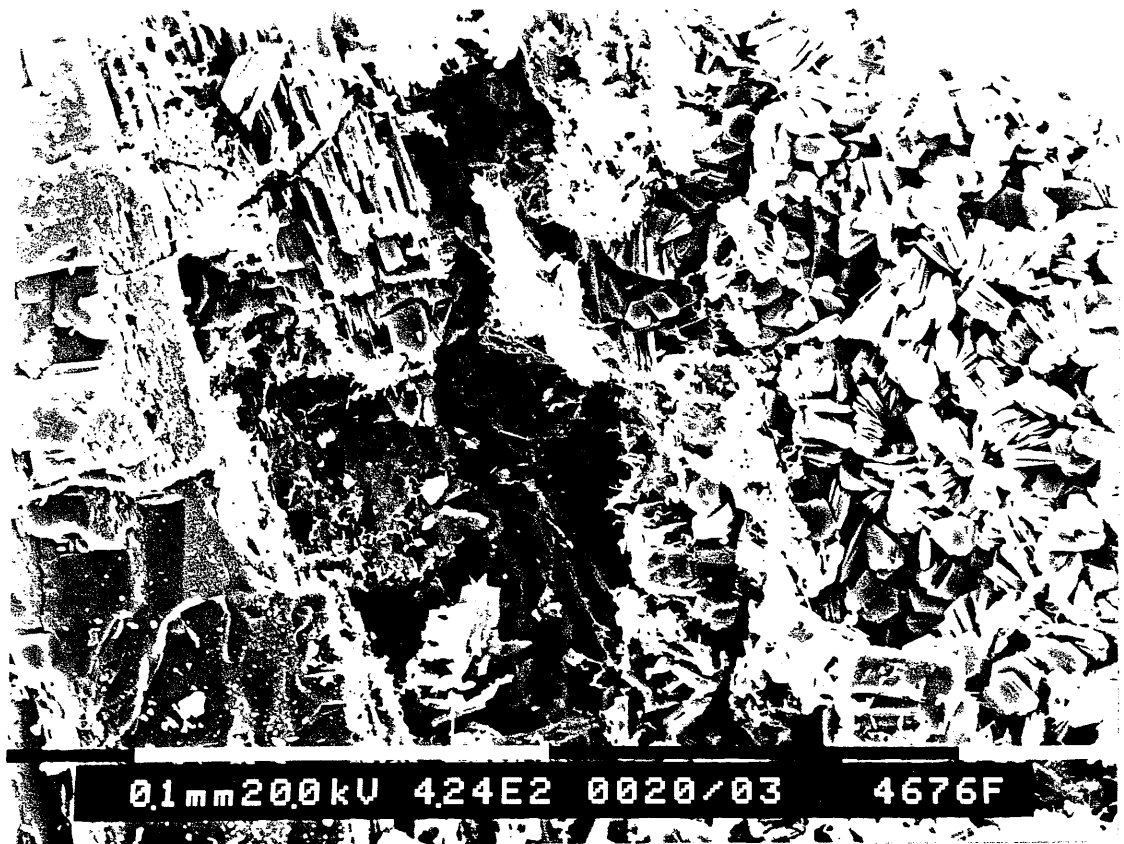
Figure 69 - Anemone #1A, junk sub sample, 4676f m. A large dissolution pore is evident in the K feldspar on the left, adjacent to kaolin and minor illite. A thin border of illite between the pore and the kaolin probably represents alteration at the original boundary of the K. feldspar.
