2-98 Anemone 1A

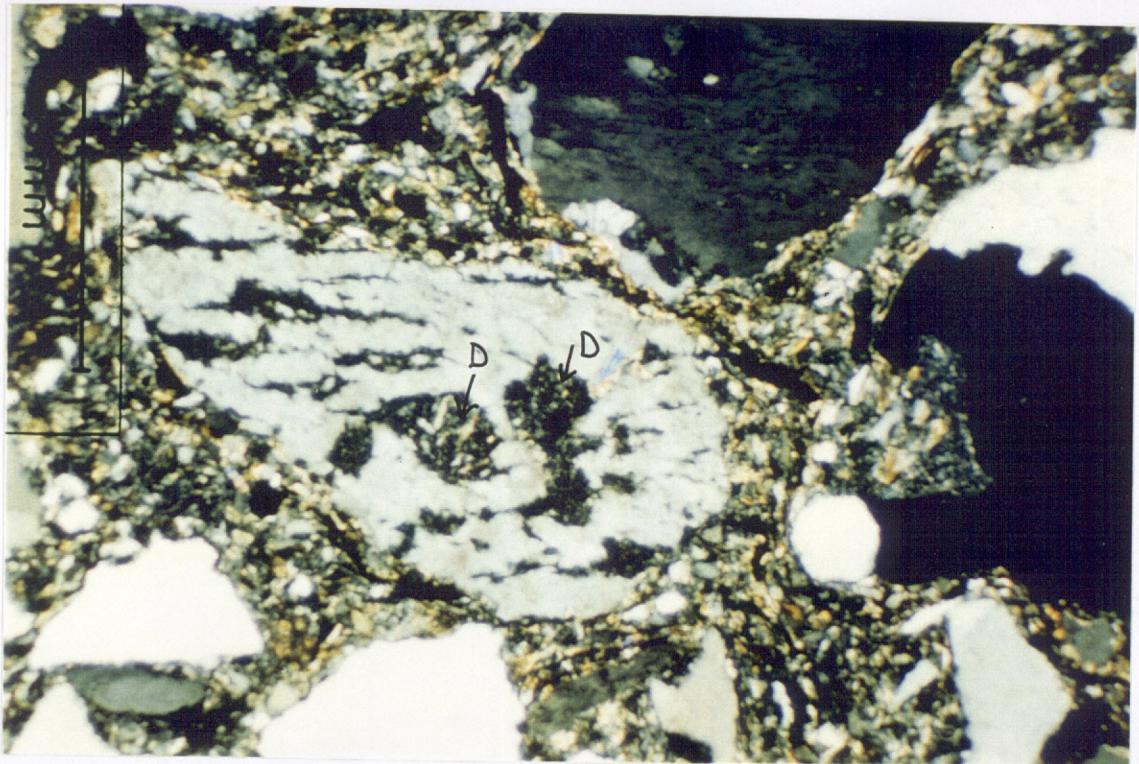
Figure 10 - Anemone #1A, junk sub sample, 4676a m. A crossed polars view of the previous photo reveals patchy alteration of microcline and the granitic fragment to dickite (D) and minor yellowish sericite. The matrix is illite rich.
