2-98 Anemone 1A

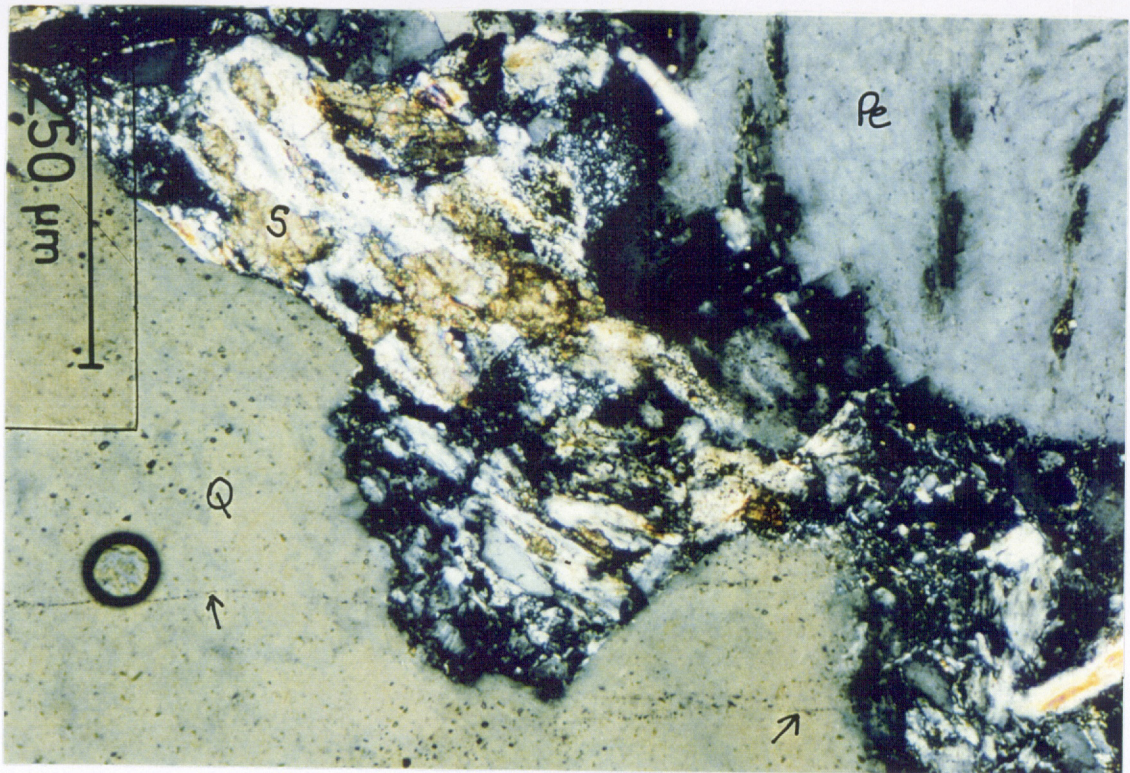
Figure 14 - Anemone #1A, junk sub sample, 4676a m. Carbonate spar (S) is corroding along cleavage of muscovite which is altering to grey chlorite. The quartz grain (Q) shows vacuole trails (arrowed) and inclusions. Dissolution is seen in the perthite grain (Pe).
