2-98 Anemone 1A

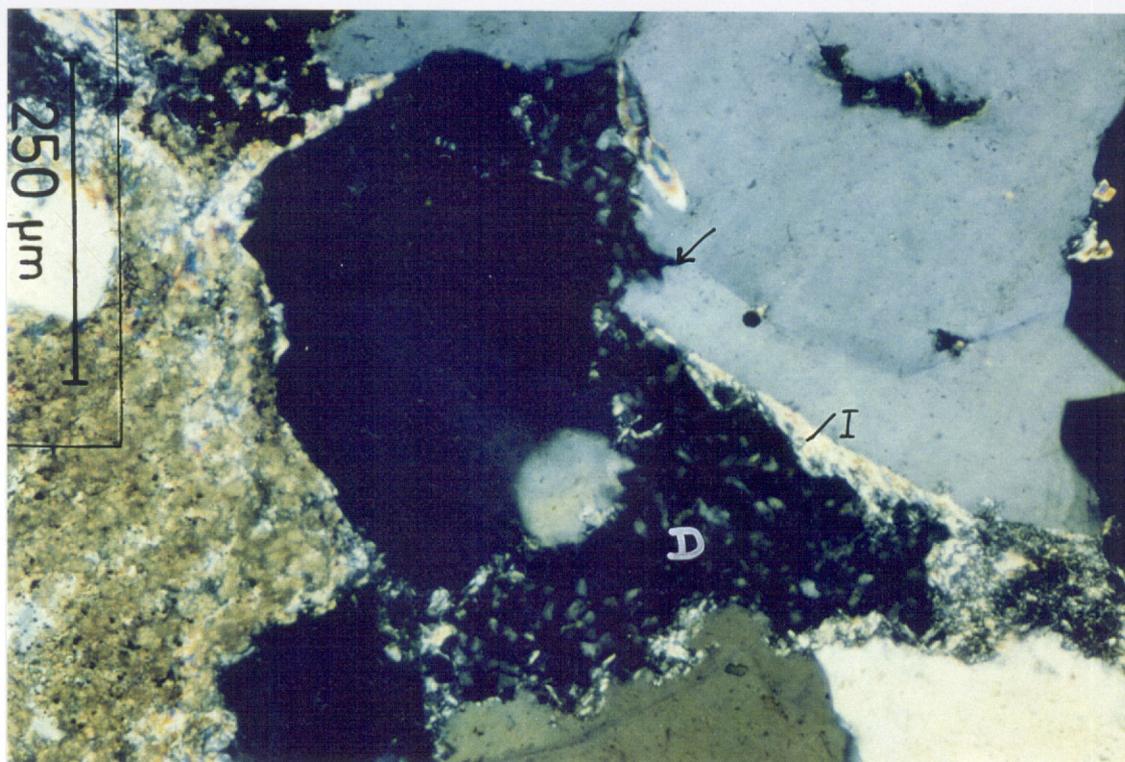
Figure 41 - Anemone #1A, junk sub sample, 4676d m. Crossed polars view revealing low birefringence (D), grain-lining illite (I) and corroded quartz (arrowed). Aggregates of fine spar on the left coincide with illite-rich or opaque-rich zones.
