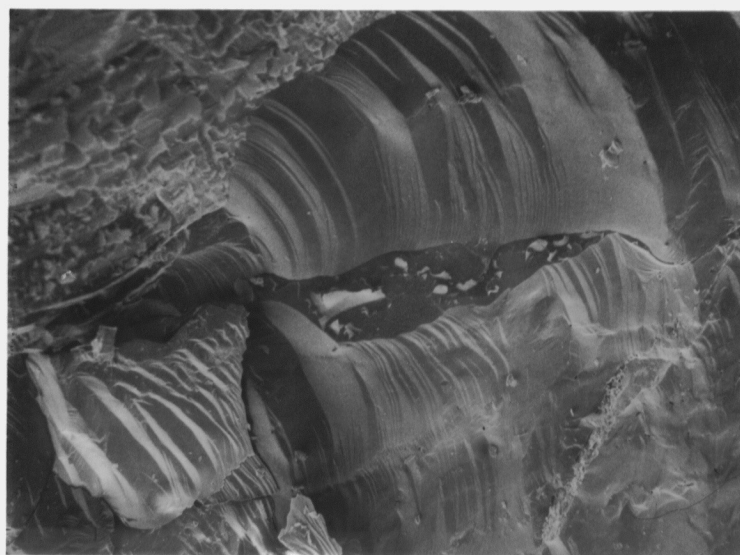
SEM Photo 3 2945m

Broken quartz macro clast with
accentuated curved fracture
development, possibly the result
of explosive sampling method.

Width of field 1000 microns.
