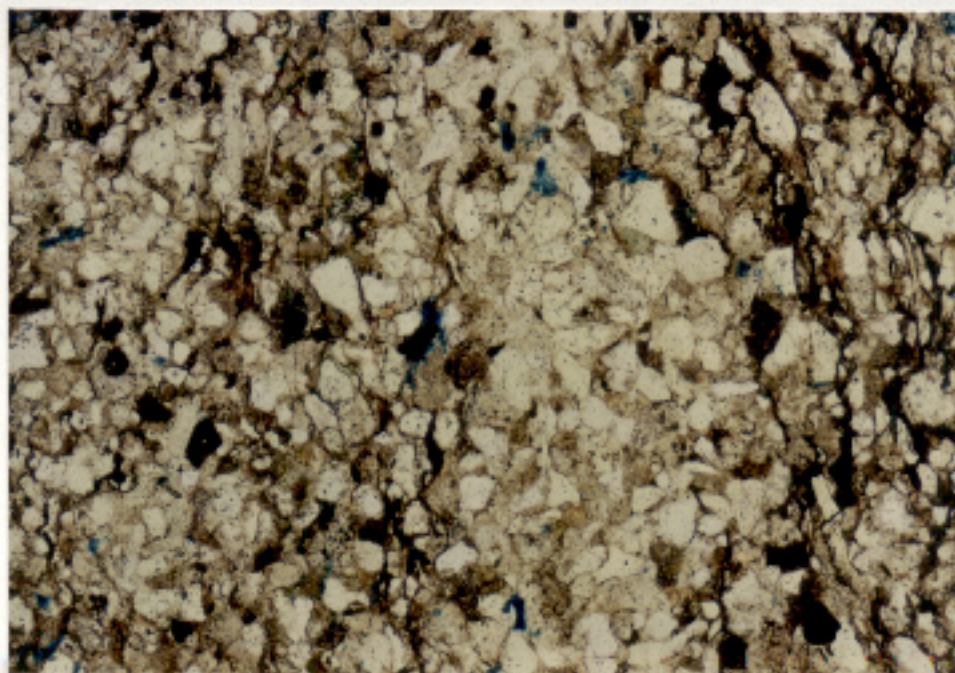
FIGURE 7(a): 2809 m (plane polarised light)
Tight, fine-grained sandstone with abundant dark material. Some of the latter is probably plant debris; more compact, smaller patches are ferruginous heavy-mineral grains.

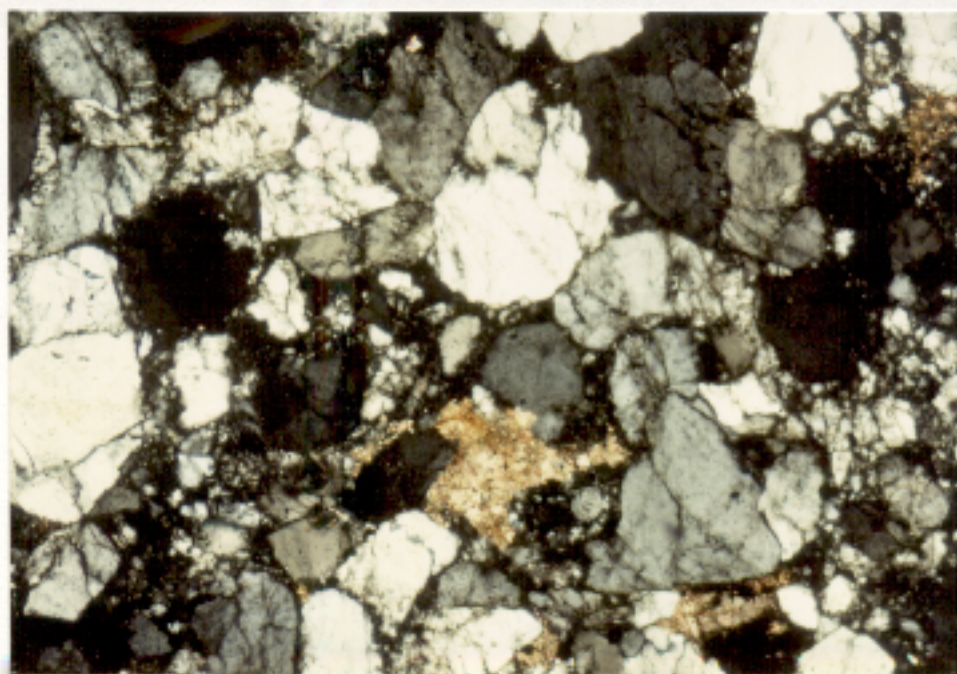
FIGURE 7(b): 2809 m (crossed Nicols)
Rather damaged material but the curved contacts between the quartz grains are well shown. Patches of carbonate occur and are probably relatively late.
