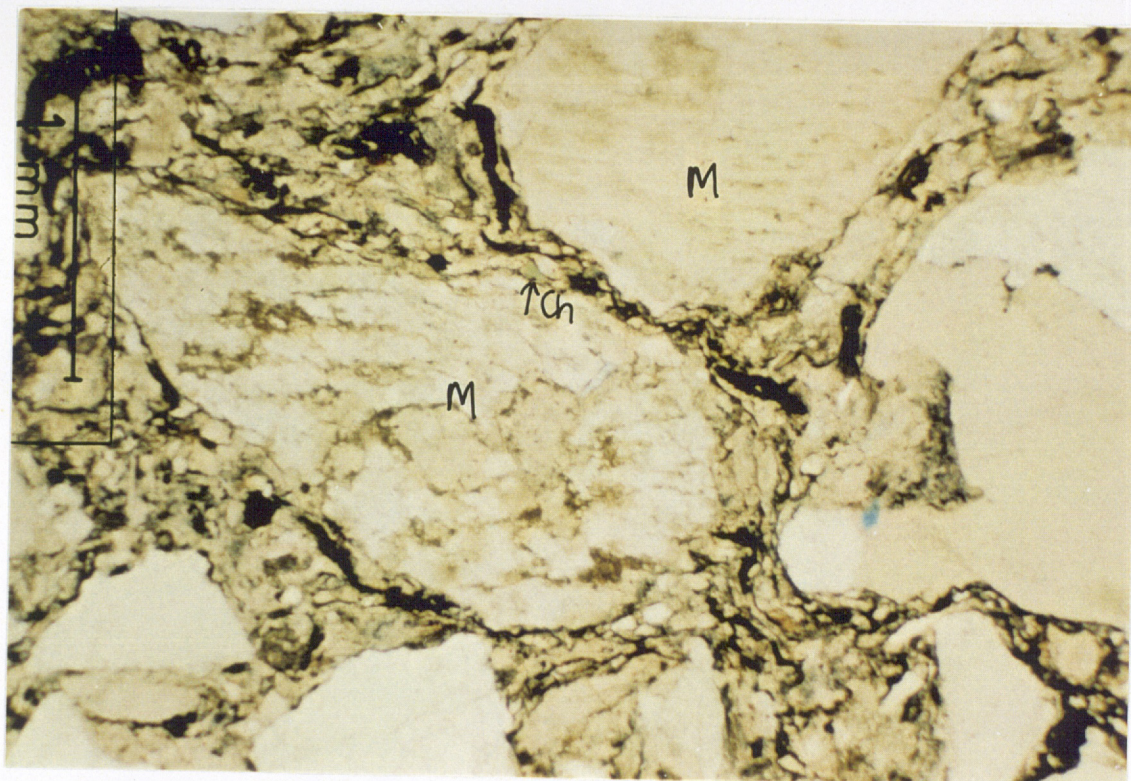
Figure 9 - Anemone #1A, junk sub sample, 4676a m. Thin section micrograph in plane polarized light showing alteration of microcline (M) and a plutonic fragment on the right. Stylolitic organic matter and fine pyrite pervade the matrix. A small lime green area of chlorite (Ch) is visible. Vague bluish areas in the matrix may be microporosity.
