2-98 Anemone 1A

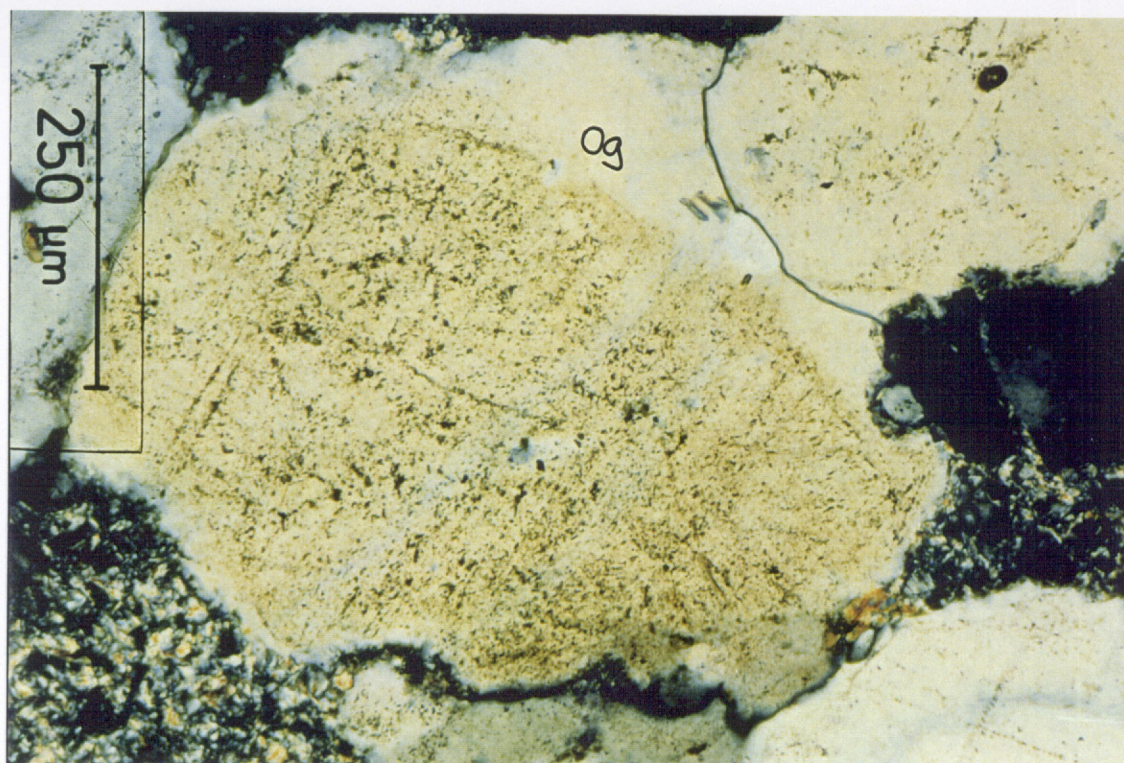
Figure 43 - Anemone #1A, junk sub sample, 4676d m. Detail of an altered quartz grain under crossed polars. A wide, unaltered, authigenic overgrowth (Og) forms a straight contact with the adjacent grain. The opposite side of the grain has a sutured contact, with the absence of an overgrowth suggesting that suturing was an earlier event.
