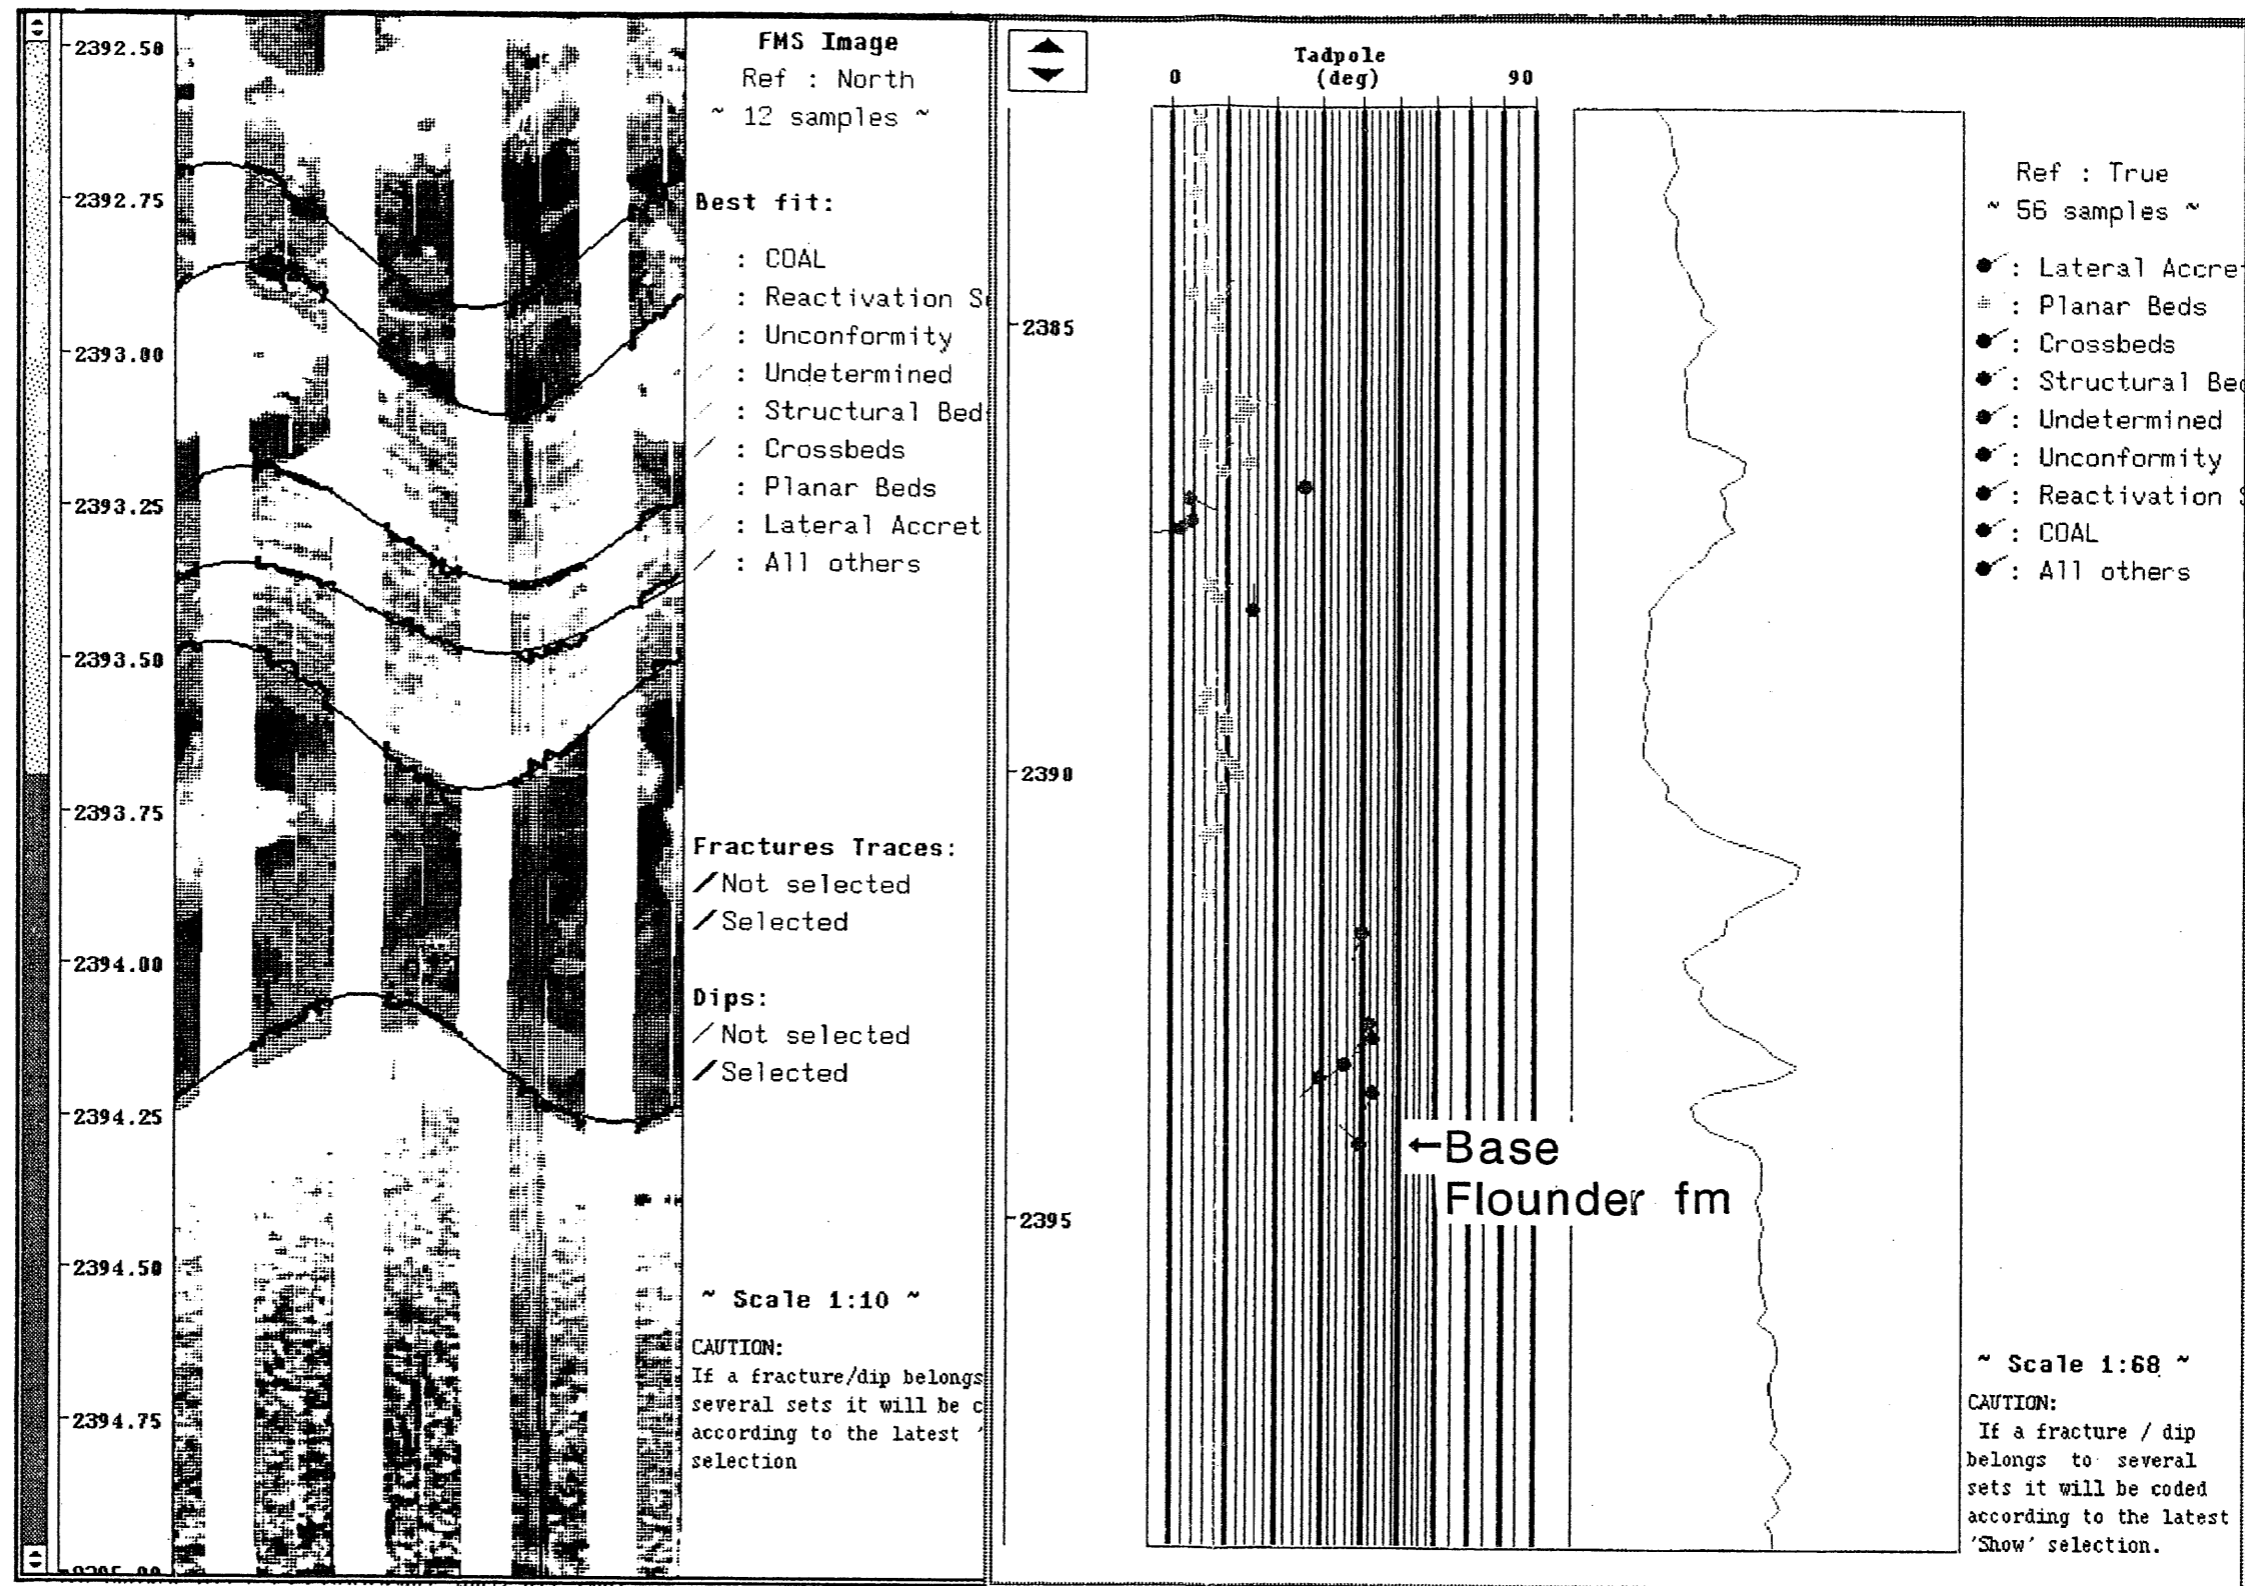
Figure 15 High angle fault locates base of Flounder formation, 2394.2m.
