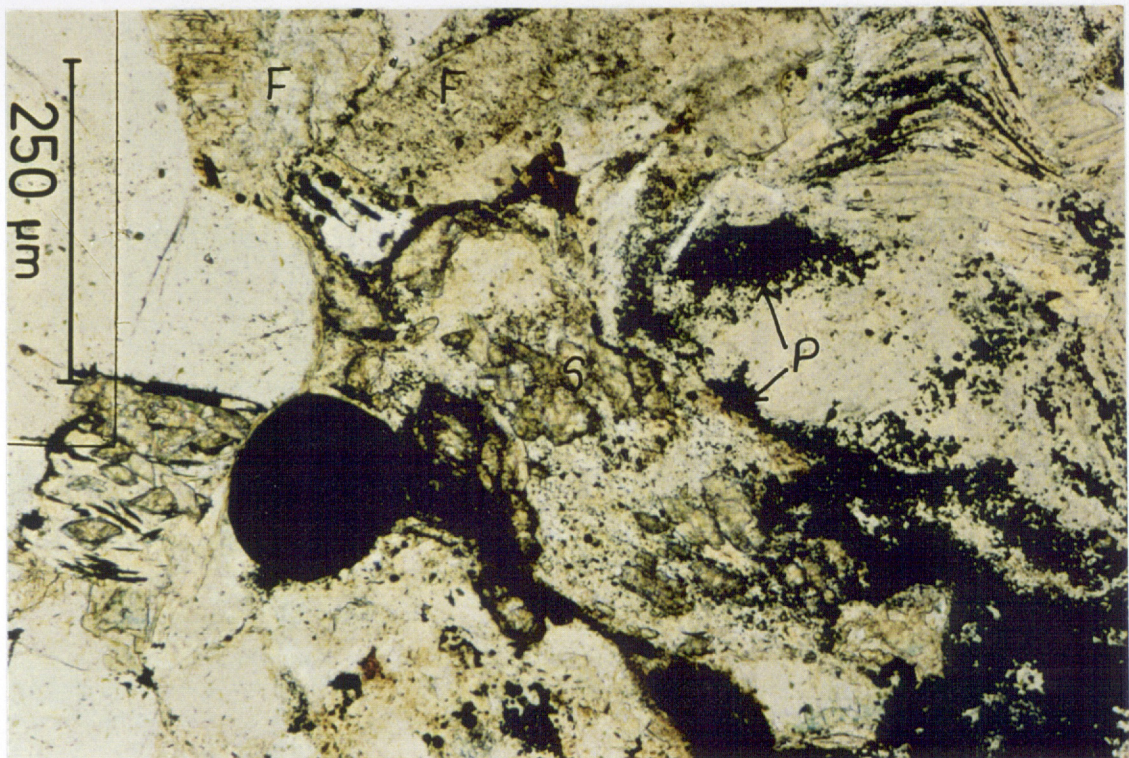
Figure 18, Anemone #1A, junk sub sample, 4676b m. Anhedrally to subhedrally carbonate spar crystals (S) are seen here invading the less competent grains. Two feldspar fragments display alteration. The bent muscovite (Mu) shows cleavage development of pyrite, which is disseminated around grain boundaries with organics. The spherical black object is probably an organic structure.
