Project Seboa 2D
Project ID 6374-Vic
Client Bass Strait
Line Name GOBS08-12-007 (7)
File Number 000
First Shot 1001 Date 09:08:27 2 Jun 2008
Last Shot 2228 Date 12:23:31 2 Jun 2008

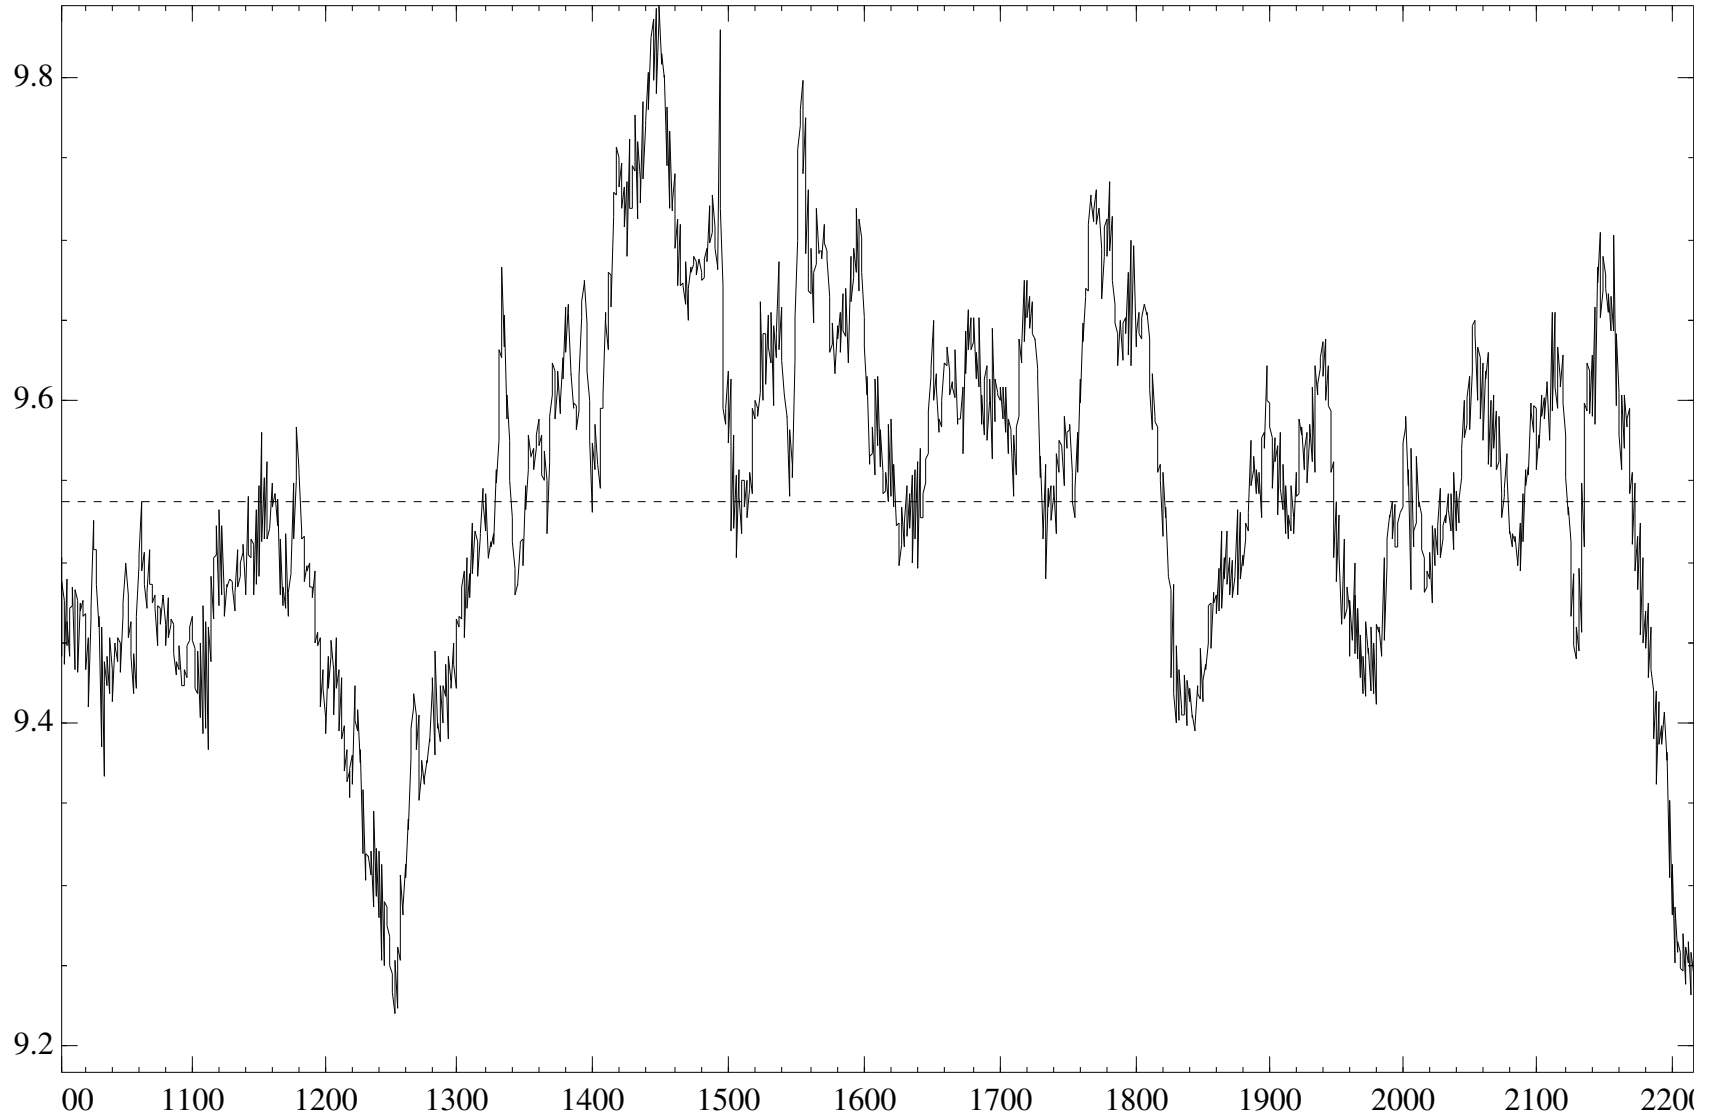
main V1 ShotTime dx

(Nobs 1228 Min: 9.183 Max: 9.844 Mean: 9.539 Sd: 0.113)

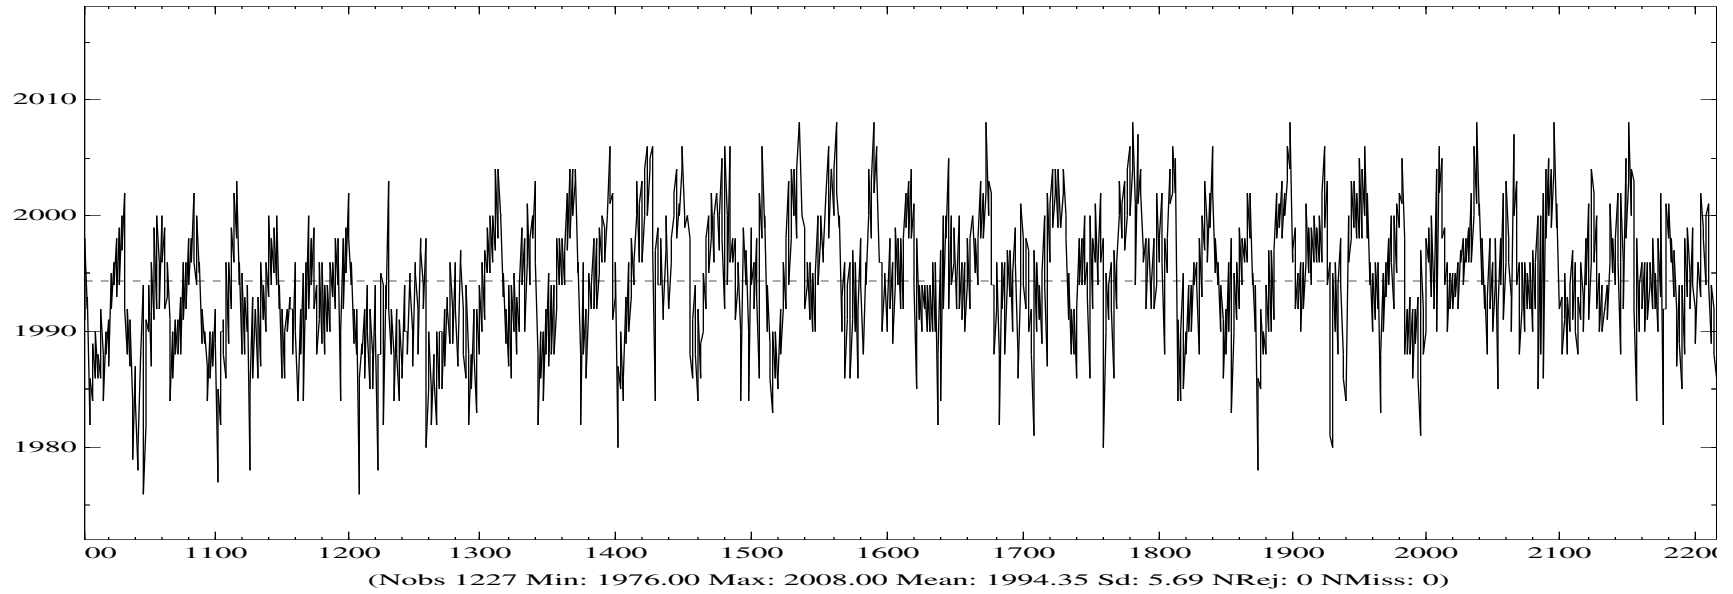
Raw: GN_SYNTRON_V2 Pressure 3 Data
