Project Seboa 2D
Project ID 6374-Vic
Client Bass Strait
Line Name GOBS08-18-004 (4)
File Number 000
First Shot 1001 Date 19:56:17 1 Jun 2008
Last Shot 1593 Date 21:25:00 1 Jun 2008

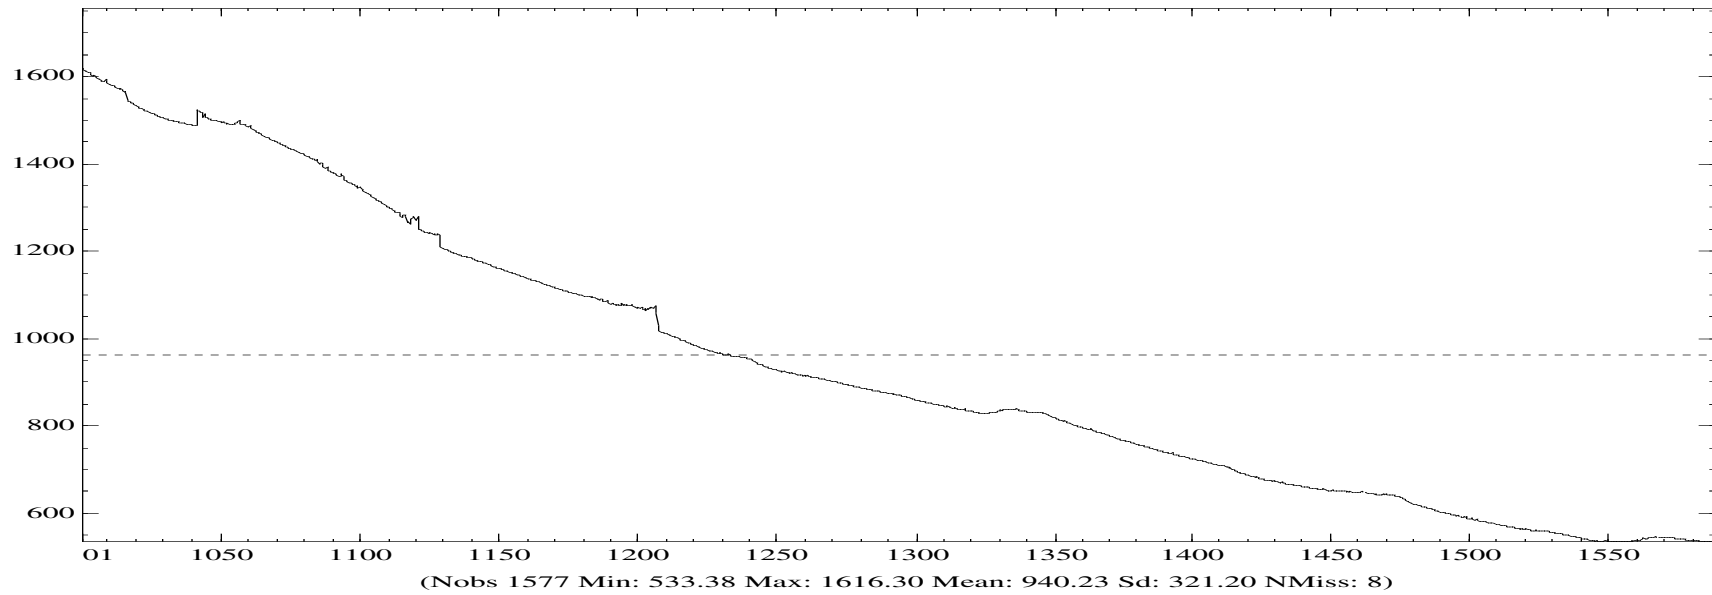
Raw: EC_EA500 DEPTH 1

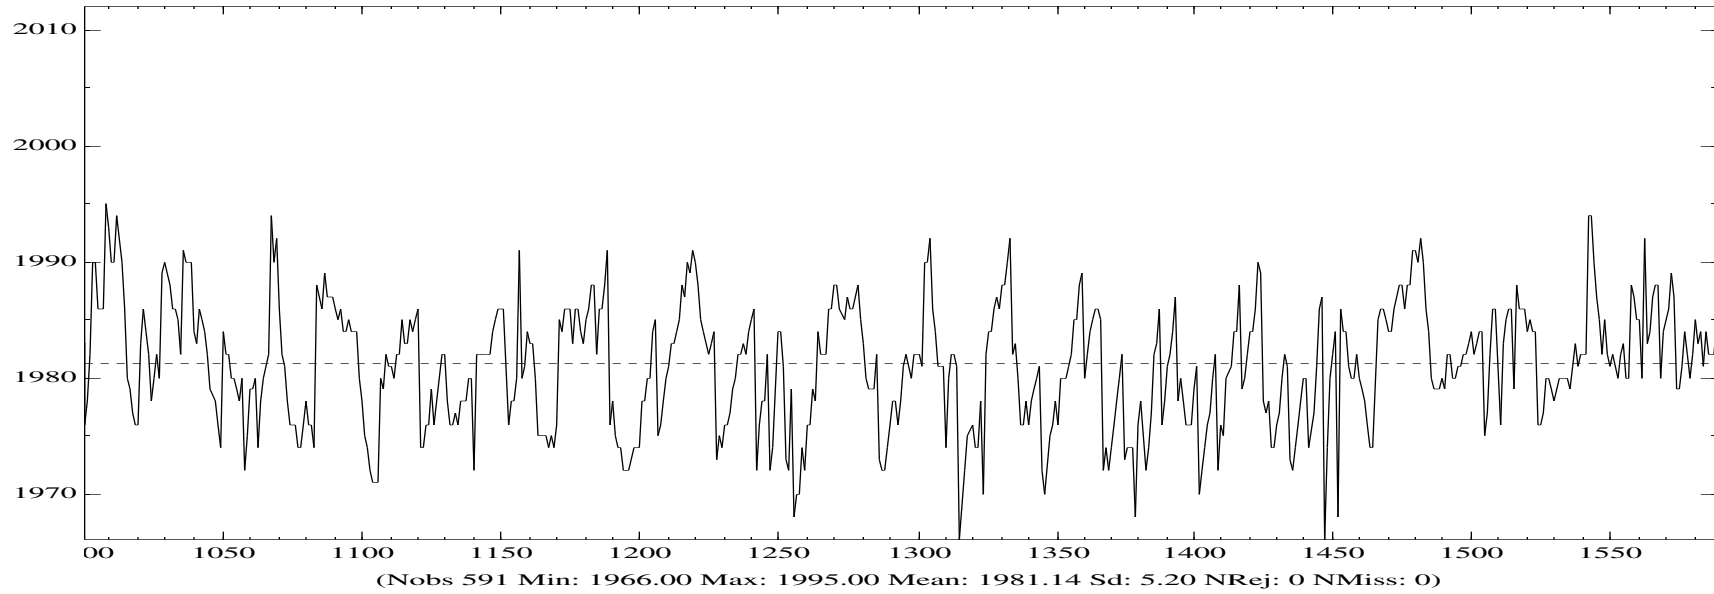
Raw: GN_SYNTRON_V2 Pressure 3 Data
